CHAMPLAIN BRIDGE

IMPACTS DUE TO POSSIBLE DELAYS OF NEW BRIDGE OPENING

2038 2038-RPT-GEN-011

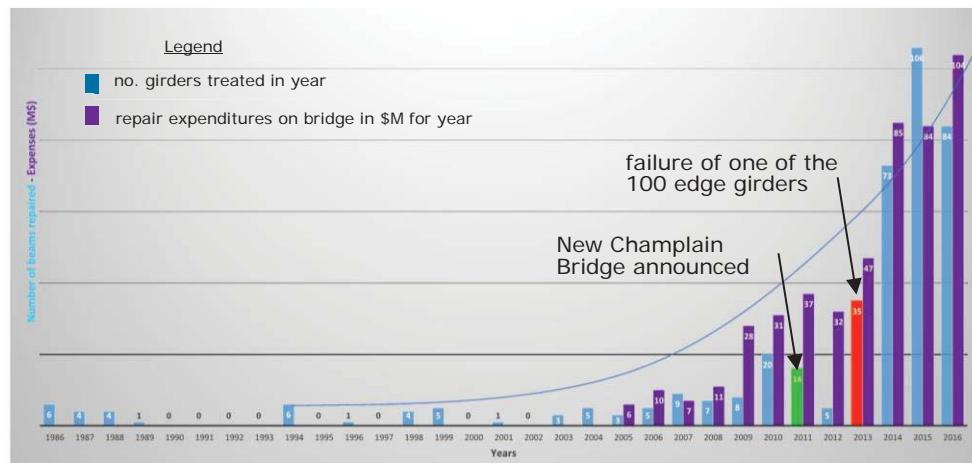
Figure 2 History of Girder Repairs for the Champlain Bridge since First Interventions in 1986

In the last 4 years, the action plan developed in 2013 has been continuously updated and additional measures have been required, due to the exponentially accelerating deterioration in the girders and piers. Figure 2 shows the number of girder interventions per year as well as the total expenditures on the overall repairs to the Champlain Bridge per year since the first interventions in 1986. This figure shows the increase in interventions over time for the girders of the Champlain Bridge that have been required to maintain user safety and keep the bridge open to traffic. This also shows JCCBI's significant investment in rehabilitating the bridge since the failure of one of the edge girders in 2013 due to continued corrosion and deterioration of the structure.

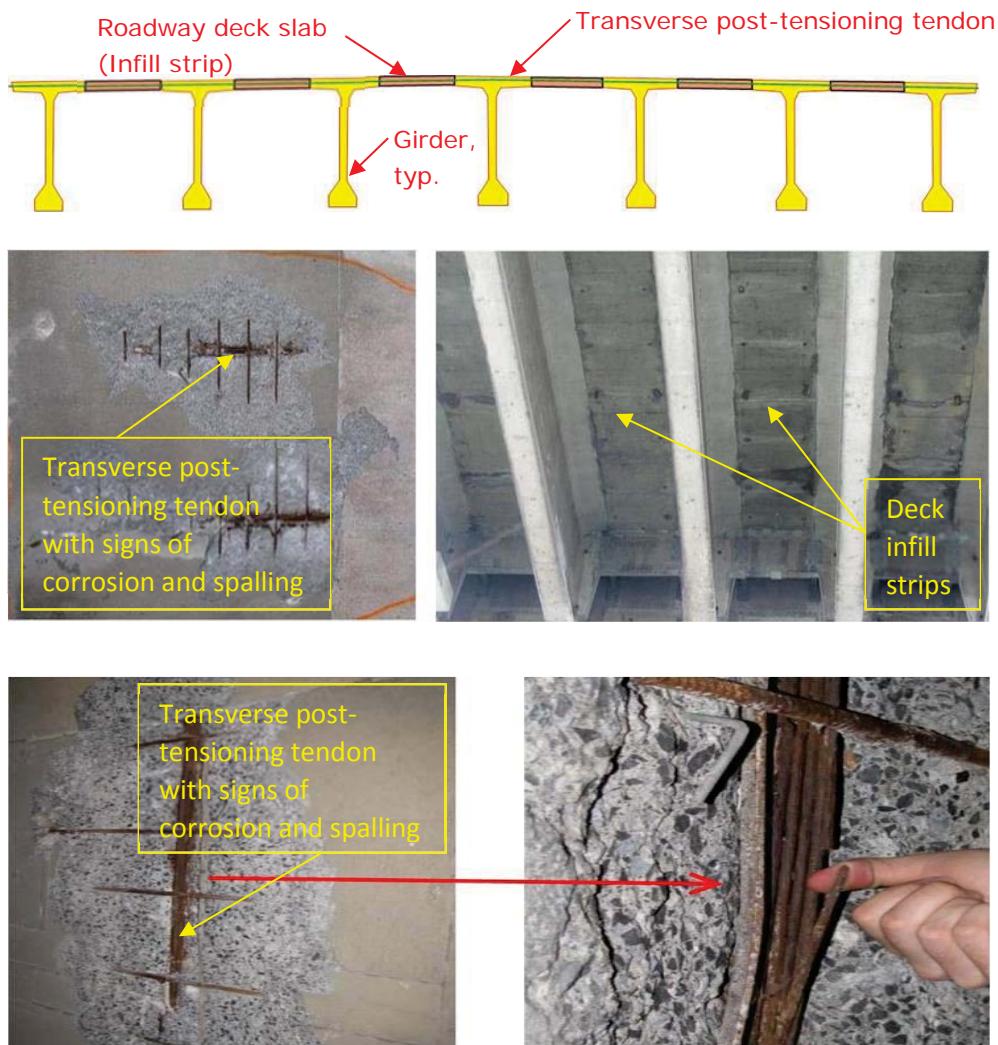
Figure 3 Observed Signs of Deterioration on Soffit of Deck Slab

Figure 3 shows typical observed signs of deterioration on the soffit of deck infill strips. At some locations, there is evidence of corrosion of the transverse post-tensioning tendons in the deck and these tendons are essential to ensure the transverse integrity of the deck slab.

COWI anticipates that the number of localized deck repairs required per year will continue to increase as time passes.

The risk associated with the deck if a serious problem is not identified by JCCBI's inspection team is a local failure in the deck. The most likely result of a local deck failure would be a short-term closure of one or two lanes of traffic (depending on the extent of the local failure).

Inspections are ongoing for the deck to help manage the risks. COWI believes that the risk of localized failure is low, and is expected to remain low under both 12 and 24 month delay scenarios, however the number of local failures needing repair will increase the longer the new bridge is delayed.

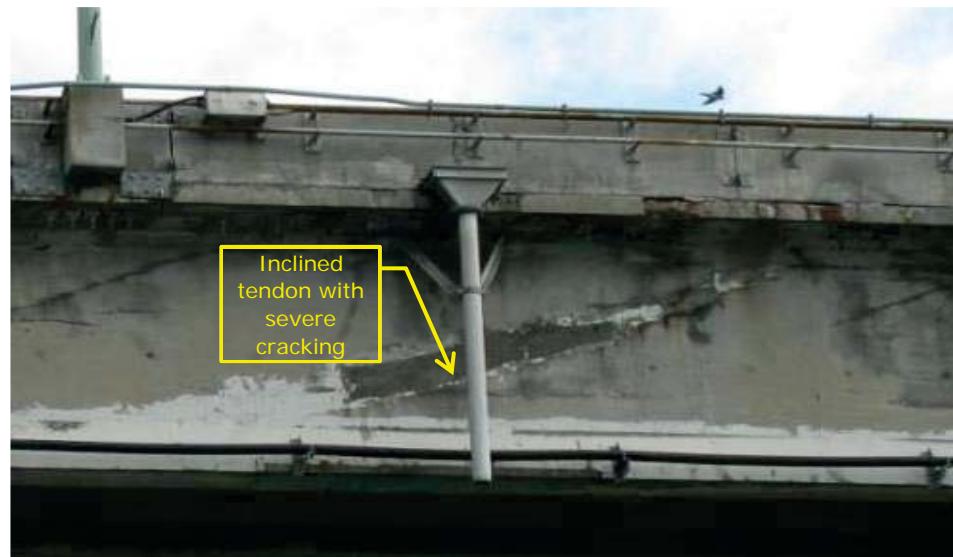
Figure 4 Severe Cracking as Sign of Deterioration of Girder Internal PT

Establishing the amount of PT section loss in a girder is very difficult since only localized openings or surface observations are possible. Although attempts have been made to use non-destructive testing to determine corrosion levels, there is still uncertainty about the actual condition and section loss of the PT tendon and as a result the strength of the girders.

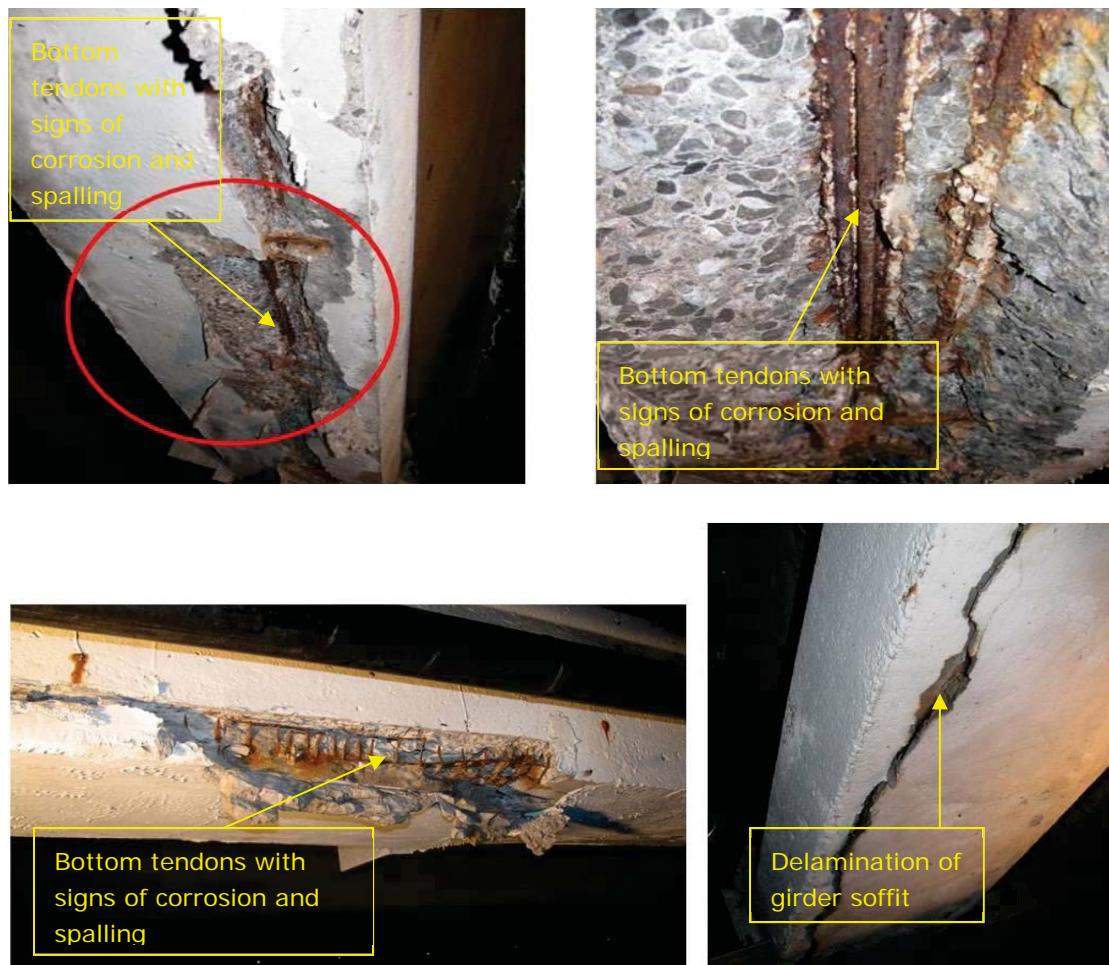
Figure 5 Observed Signs of Deterioration of Edge Girders

In 2013 a very alarming structural failure occurred to one of the 100 edge girders. Fortunately, as part of JCCBI's proactive approach to managing the deterioration of the bridge, a steel support girder ("Superbeam") had been fabricated in 2009 and stored near the bridge, ready to be used in the event of such a failure. Following this girder failure, JCCBI updated its risk mitigation program and launched a major girder strengthening campaign to ensure structural integrity of all 100 edge girders.

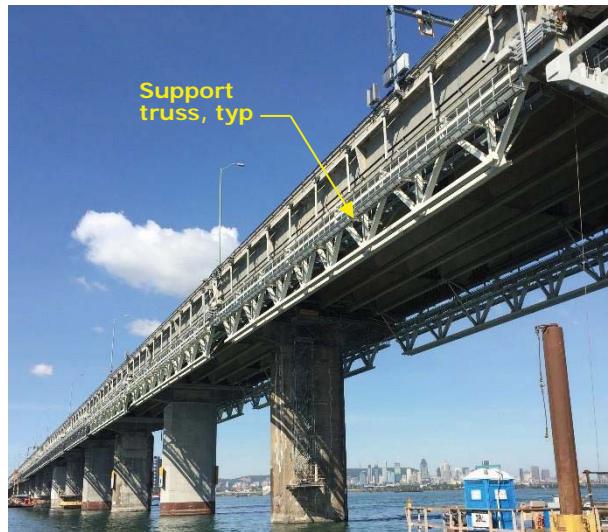
Figure 6 Support Trusses Installed under Concrete Edge Girders

In the last 4 years, support trusses (see Figure 6) have been placed under all concrete edge girders except for four spans where other strengthening systems were more suitable or cost-effective and these trusses have been designed to carry the entire load that would result from an edge girder failure. Since truss installation was completed on all spans in March 2017, the risk of an edge girder failure has been effectively dealt with, and is considered to be very low (and is expected to remain very low under both the 12 and 24 month delay scenarios). However COWI continues to monitor the behaviour of all 100 concrete edge girders on a daily basis

using sensors and a sophisticated monitoring system to assess any changes to the girder deformations.

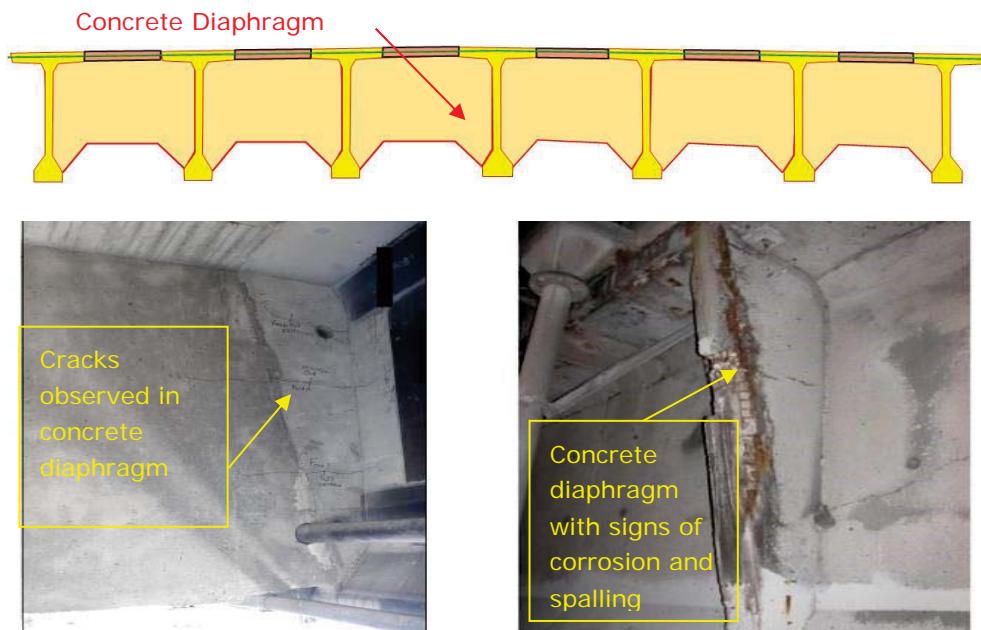
Figure 7 Observed Signs of Deterioration on Concrete Diaphragms

Many of the 1272 concrete diaphragms between the girders in Sections 5 and 7 are in poor condition and show signs of significant deterioration (see Figure 7). At some locations, corrosion of reinforcement, concrete spalling and cracking have been observed. The concrete diaphragms provide load sharing between girders under traffic, and deterioration to these components increase the girder demands and, in turn, the risk. In the last 4 years, many of the diaphragms have been strengthened.

COWI considers that there is a medium risk of failure of a concrete diaphragm and that this will increase to high risk with any delays to the new bridge if the current mitigation measures are followed.

The consequence of a failed concrete diaphragm may require a lane closure on the bridge until it is rehabilitated. JCCBI continues to carry out frequent inspections to closely monitor for signs of distress in the diaphragms so that strengthening measures can be implemented. In the event of a failed diaphragm, JCCBI has tasked COWI with developing concepts for an emergency replacement diaphragm as part of the updated risk mitigation program. As such, COWI considers that the risk of failure of a concrete diaphragm risk will remain medium under the 12 and 24 month delay scenarios if the updated mitigation plan outlined in Appendix A is followed.

- 9 Design and fabricate by summer 2018 an emergency standby truss to be installed between piers under an interior girder, if the need arises.
- 10 Design and fabricate an emergency replacement diaphragm to be installed on a distressed diaphragm, if the need arises.

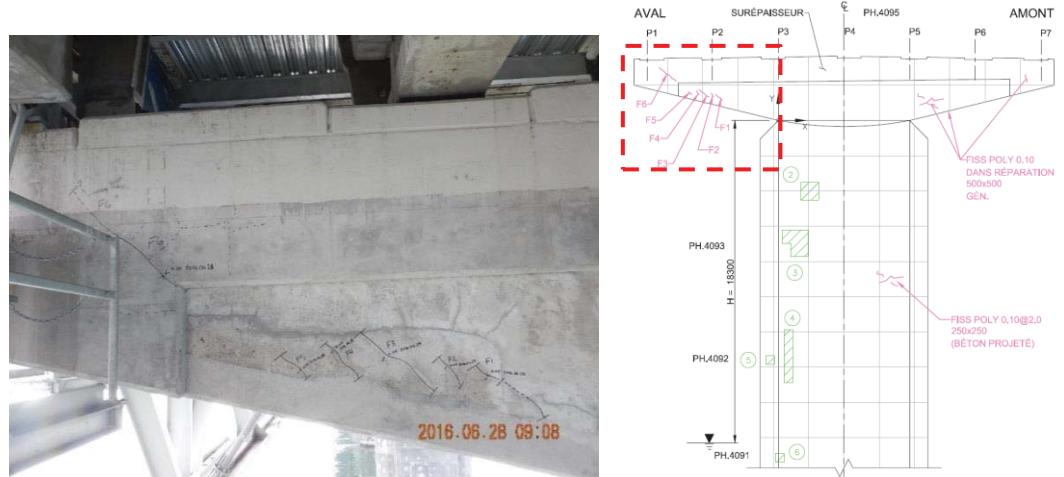
Figure 8 Observed Signs of Deterioration on Pier Caps [REDACTED] shown)

At the time, significant deterioration of the pier caps, including structural cracking, was observed. Recent inspections of the pier caps have identified cracks that could be a sign of structural distress (see Figure 8).

Even with the retrofits and strengthening systems that have been added to the pier caps, they are very highly stressed. In addition, due to the ongoing deterioration there is a possibility that unseen defects exist within the pier caps that would potentially affect their load carrying capacity. Since the pier caps have no redundancy, severe distress of a pier cap would result in a complete closure of the bridge, and a complete failure of a pier cap would result in the collapse of two spans of the bridge.

COWI considers the risk associated with the pier caps to be medium. If the current mitigation measures are followed, under a 12 month delay, this would become high and under a 24 month delay, it would become very high. If the updated risk mitigation plan included in Appendix A is followed, COWI considers that the risk associated with the pier caps will become low by the end of 2018 as all of the pier caps will be retrofitted by then.

- 5 As soon as possible, fabricate a set of retrofit measures that can serve as an emergency repair for the pier caps in Section 5 and 7 in the event that a sudden failure needs to be addressed. Target completion of design by mid-October 2017, and fabrication by end of February 2018.
