SECTION 5, 7A and 7B OF CHAMPLAIN BRIDGE
- 2D NON-LINEAR ANALYSES OF EDGE GIRDERS

REPORT SUBMITTED TO:

Ponts Jacques Cartier et Champlain Inc.

March 18, 2016

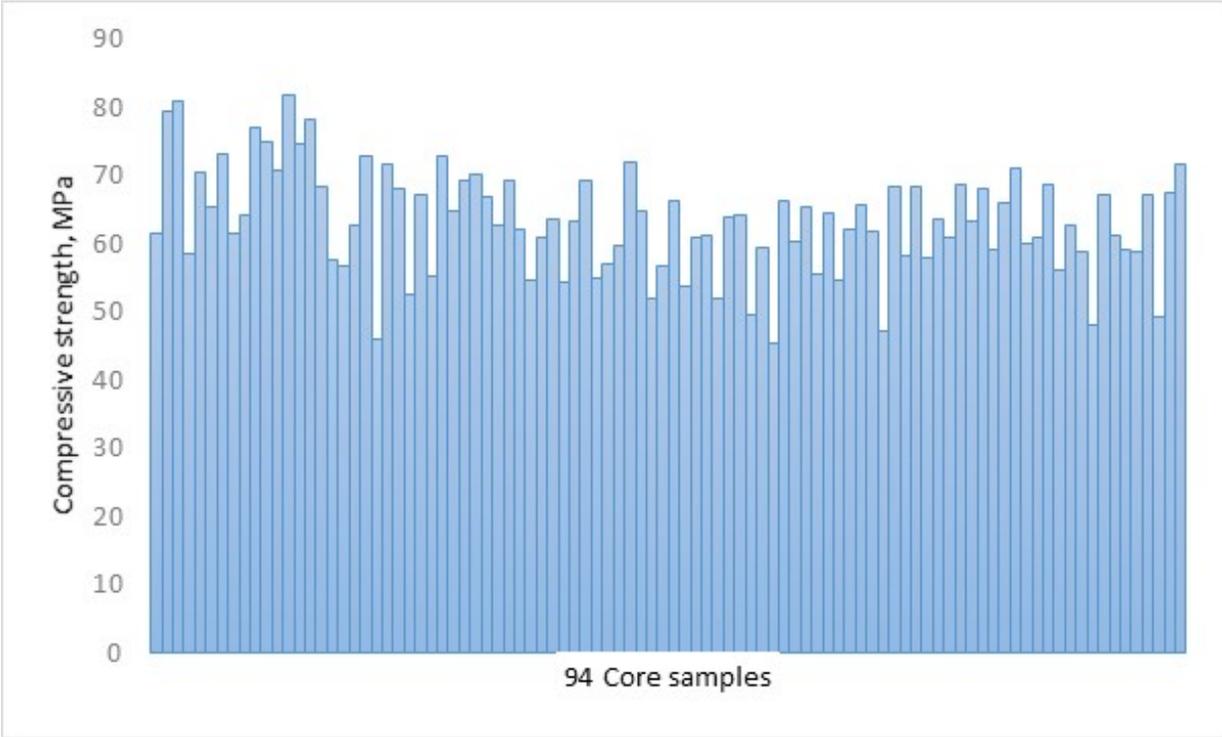
1. Figure 2.1 shows the concrete compressive strengths obtained from 94 core samples taken from girders in Section 5.

Fig. 2.1: Concrete compressive strengths obtained from core samples in Section 5 of bridge.

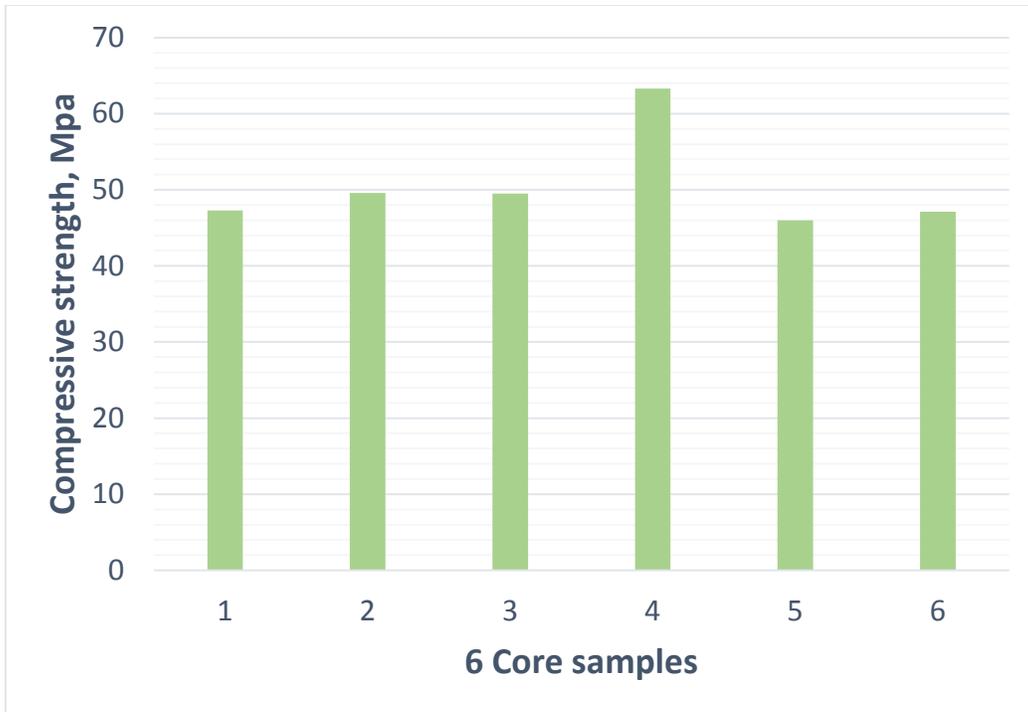
Figure 2.2 shows the concrete compressive strengths obtained from 6 core samples taken from girders in Section 7A.

Fig. 2.2: Concrete compressive strengths obtained from core samples in Section 7A of bridge.

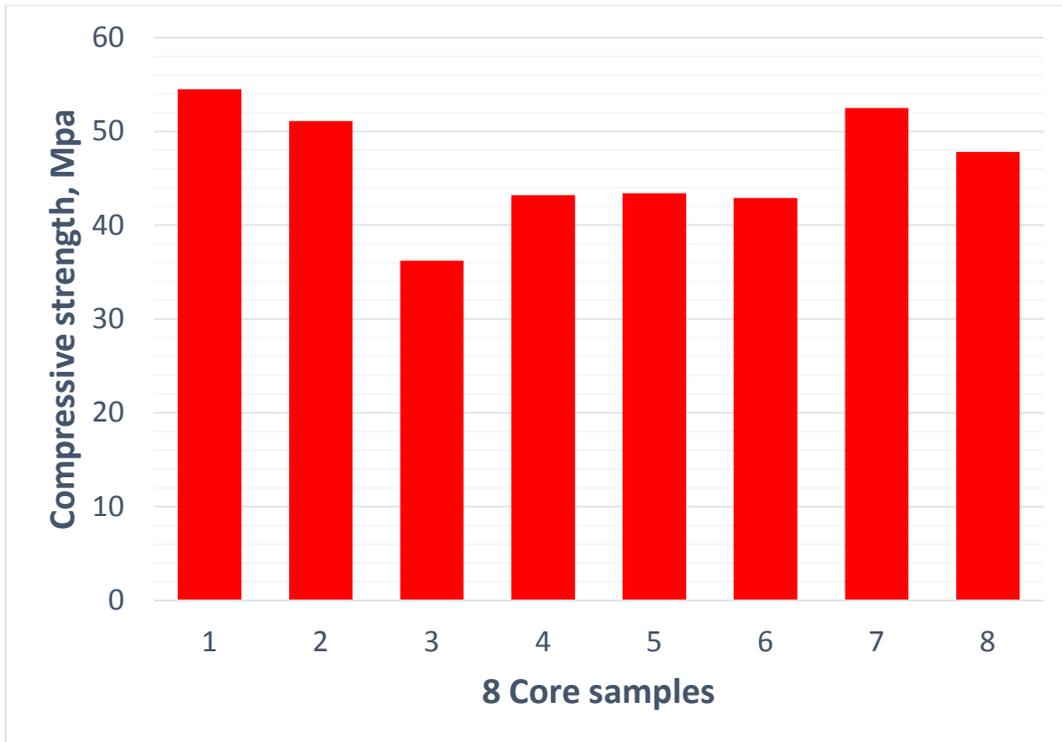
Figure 2.3 shows the concrete compressive strengths obtained from 8 core samples taken from girders in Section 7A.

Fig. 2.3: Concrete compressive strengths obtained from core samples in Section 7B of bridge.

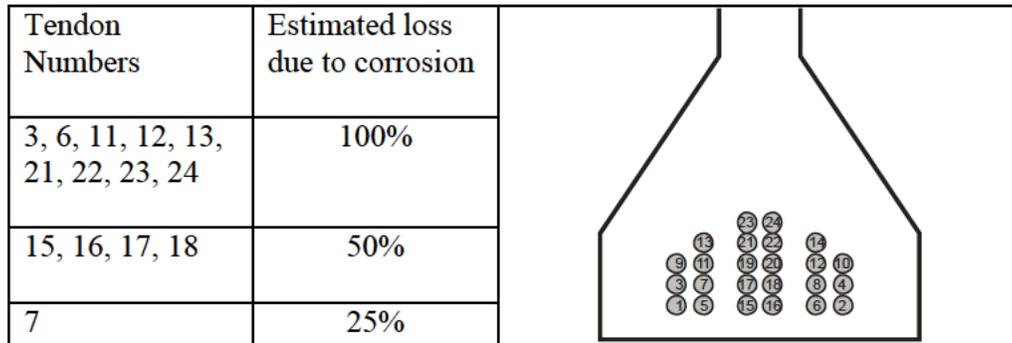
Fig. 3.1: Assumed Degree of corrosion at midspan in girder P7 of span 28W-29W (December 2014)

Observations for this girder on site and access holes in the web of P7 indicate that the corrosion of the tendons outside of the midspan region had somewhat less corrosion than the tendons in the midspan region. This inspection also revealed that there was some corrosion of the stirrups.

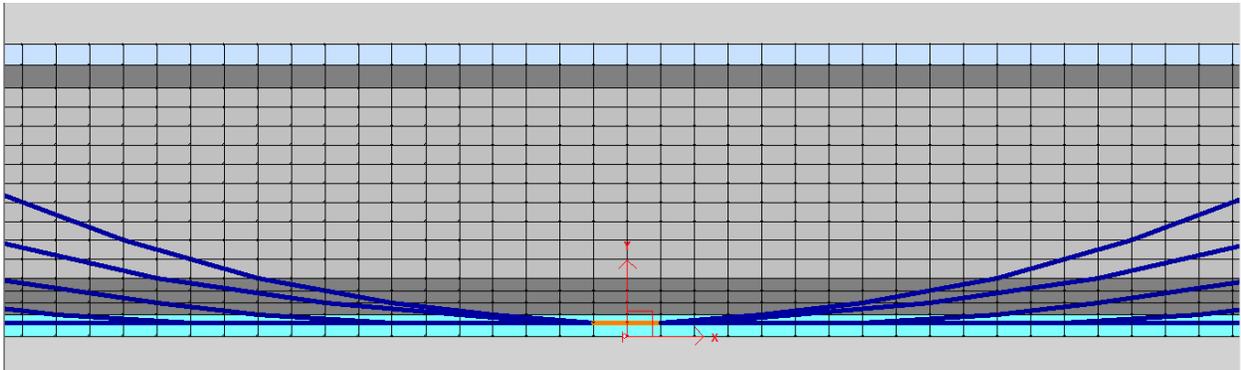
midspan due to corrosion leaving 12.75 tendons. This represents a loss of 46.9% of the tendons at midspan. A uniform degree of corrosion of 40% of the tendons was assumed for the tendons outside of the midspan region. In addition, a uniform degree of corrosion of 40% was assumed for the stirrups.

Figure 5.4 shows the modelling of the loss of tendons due to corrosion, with the tendons in the midspan region (orange colour) indicating the concentrated corrosion assumed at midspan. In addition the cross-sectional areas of the stirrup reinforcement were reduced by 40%.

Fig. 5.4: Modelling of corroded tendons

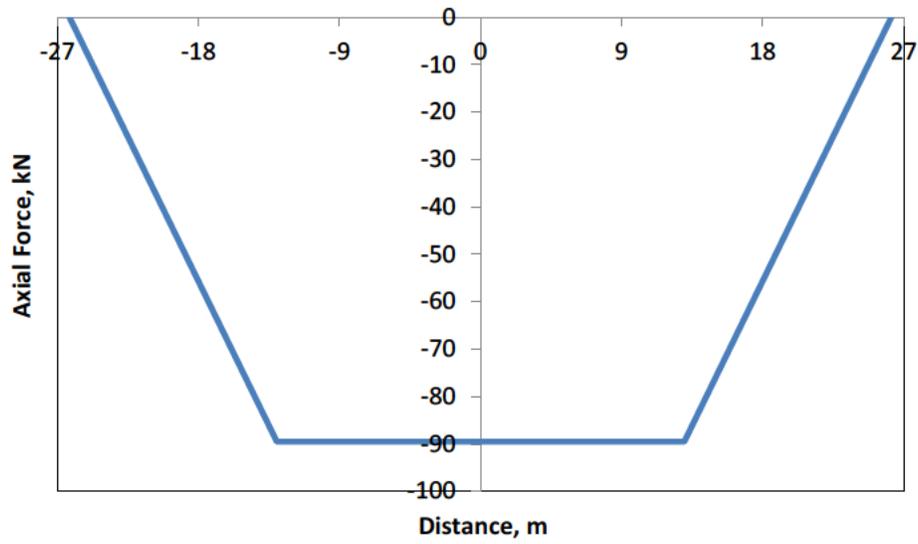
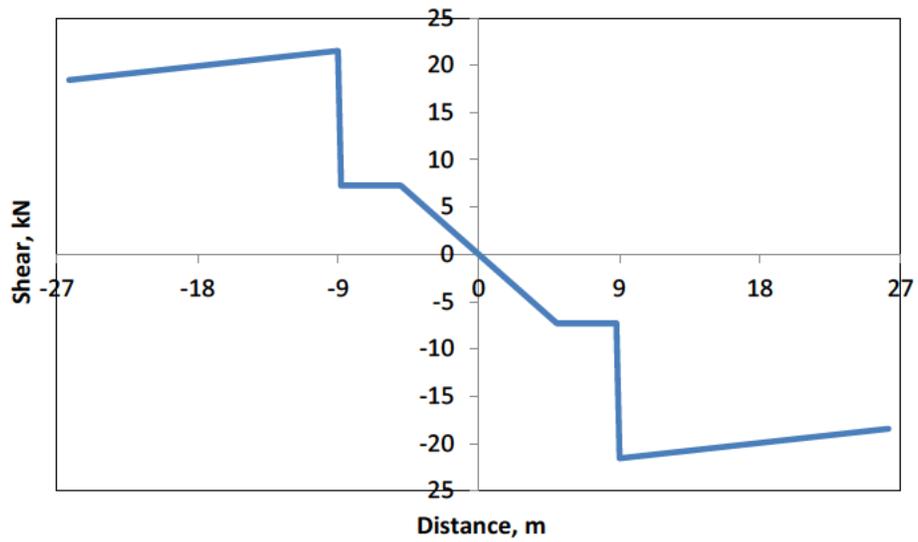
It is noted that the loss of tendons due to corrosion in an exterior girder will cause restraint effects from the remaining six girders that are connected to the edge girder by the diaphragms and the deck. To account for this effect in the 3D model a 1000 kN unit tensile force was applied to the girder at the centre of gravity of the prestressing at locations 4 m on either side of midspan of the girder. This unit tensile force of 1000 kN was applied in the 3D model to girder P1 to study the effects of restraint from the other girders. In addition, a separate force of 1000 kN was applied to girder P7 to represent tendon losses in this girder. This technique was used to determine the restraint effects in girder P7 due to tendon losses in girders P1 and P7. Figures 5.5 and 5.6 show the resulting restraint actions on P7 due to the 1000 kN force on P7 and P1 from the 3D analyses.

(a) Axial load

(b) Shear

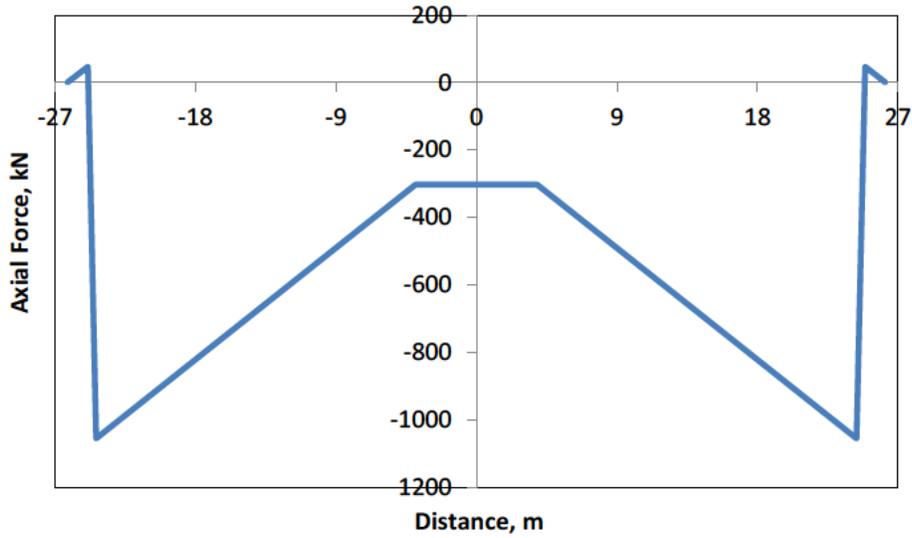
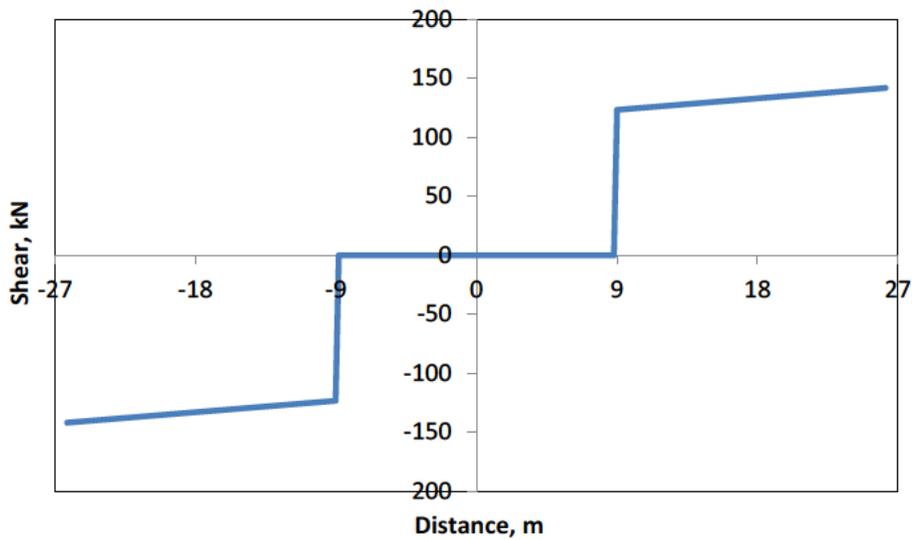
Figure 6.4 shows the axial force and shear force diagrams corresponding to the forces applied to the 2D model of girder P7 to simulate the external horizontal post-tensioning. Figure 6.5 shows the forces applied to the 2D model to simulate the effects of PTE on P7.

Fig. 6.4: Axial force and shear force diagrams corresponding to the forces applied to the 2D model of girder P7 to simulate the external horizontal post-tensioning.

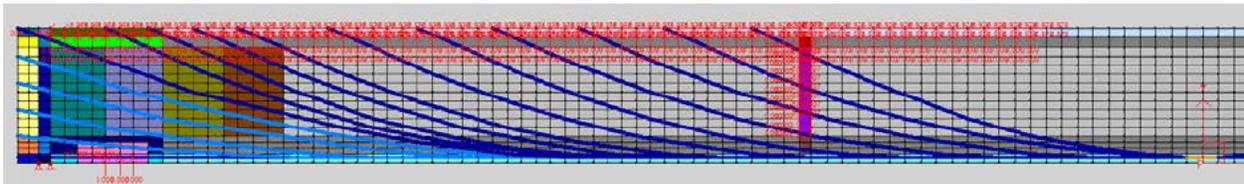
Fig. 6.5 Forces applied to girder P7 to simulate the PTE on Girders P7 and P1.

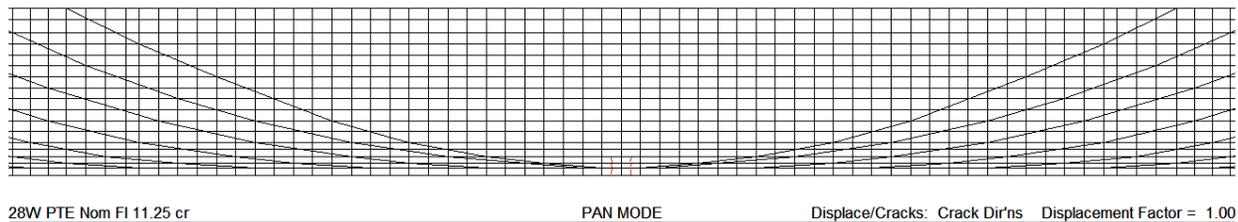
Fig. 6.6: Cracking predictions for maximum moment at midspan for short-term service loads with corroded tendons and corroded stirrups, strengthened with PTE.

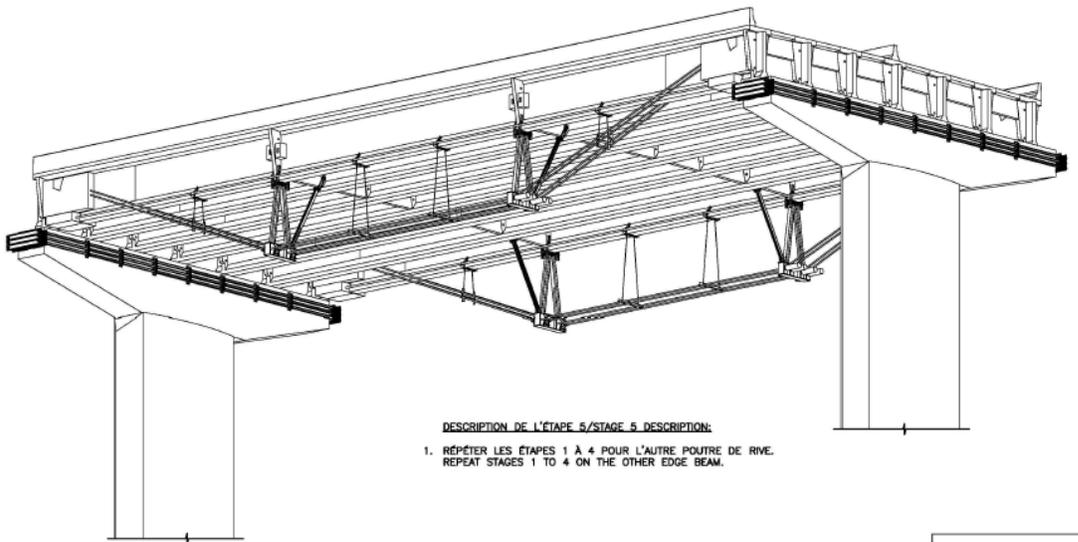
The overall length of the girders in Section 5 is 176'-0", resulting in a centre-to-centre span of 172'-0". Figure 7.1 shows the general aspects of the strengthening using QP1 (AECOM 2011). The post-tensioning consisted of 4 - 36 mm diameter high-strength bars (1035 MPa ultimate strength) on each external girder, P1 and P7.

Fig. 7.1: Queen Post 1 Strengthening (AECOM 2011)

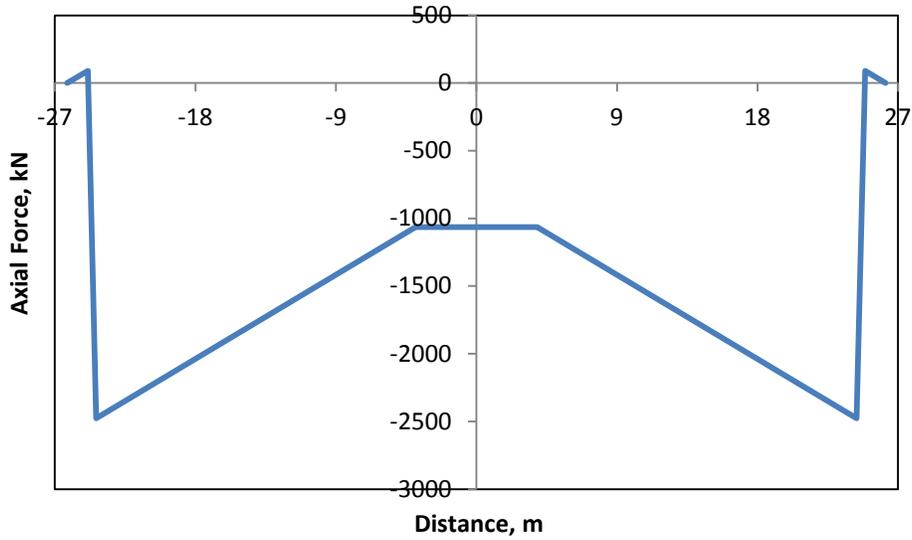
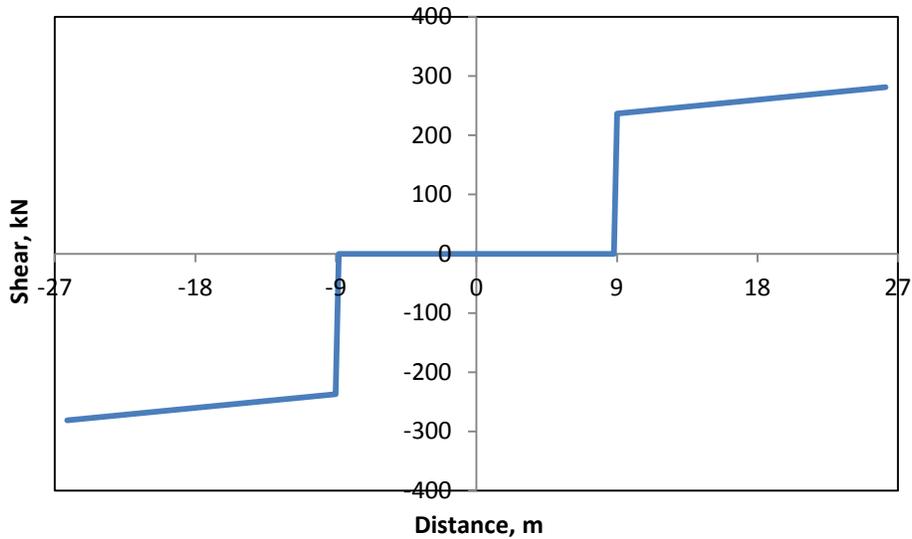
Figure 7.5 shows the axial load and shear force diagrams corresponding to the loads applied to the girder to simulate the loading case for the PTE on P7.

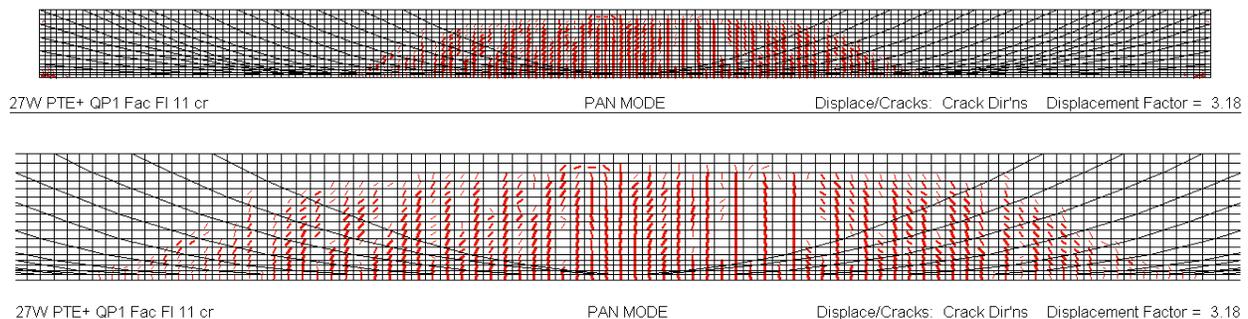
Figure 7.6 shows the crack patterns at the maximum factored loading that girder P7 can carry. The girder reached a factored load corresponding to factored dead loading plus 3.18 times the live load. The D/C ratio is 0.70.

Fig. 7.6: Crack patterns at maximum factored resistance corresponding to factored dead load plus 3.18 times service live load. Corrosion considered (P7 in span 27W-28W).

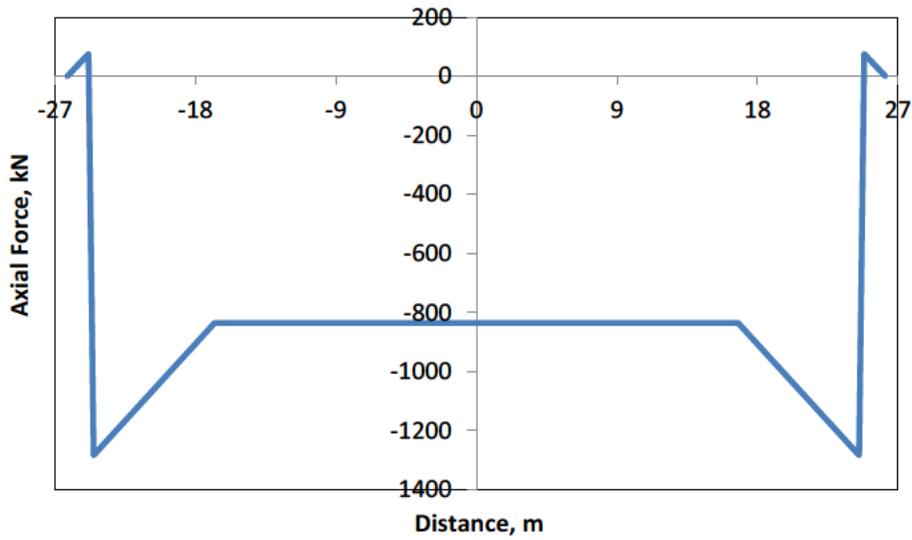
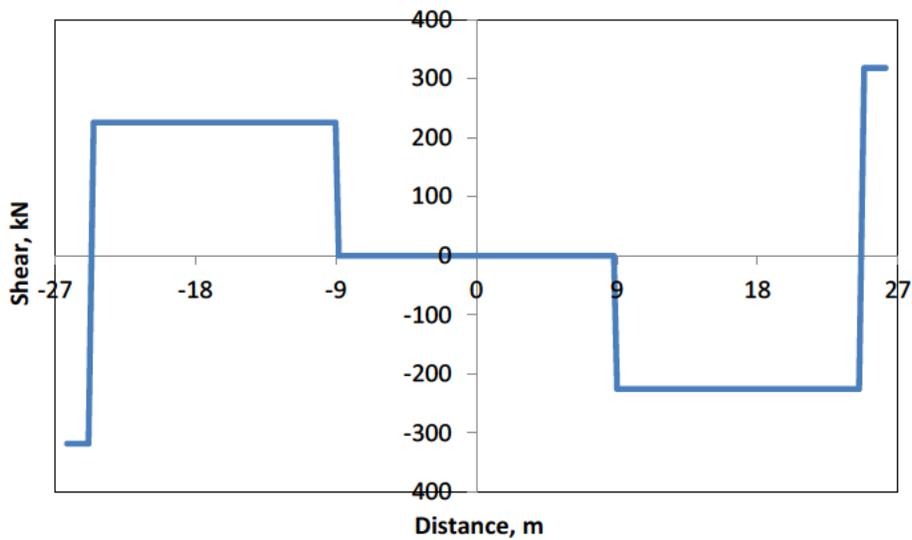
Figure 7.7 shows the forces applied to simulate the the 1360 kN QP1.

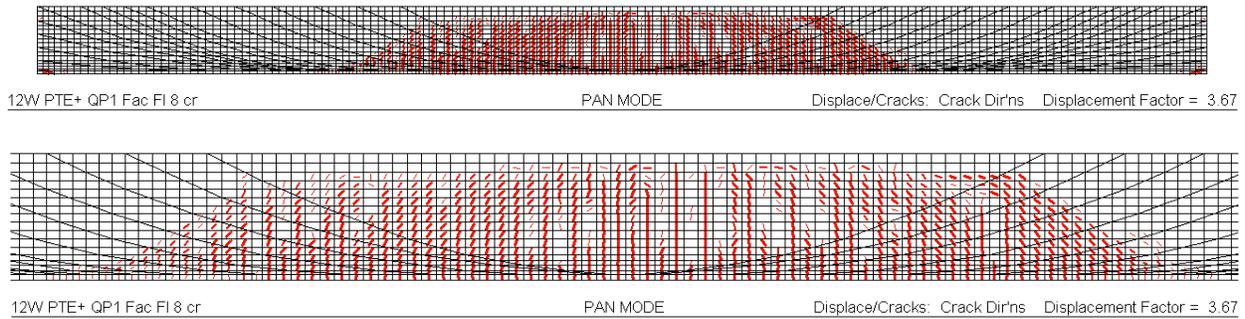
Figure 7.9 shows the crack patterns at the maximum factored loading that girder P1 can carry. The girder reached a factored load corresponding to factored dead loading plus 3.67 times the live load. This corresponds to a D/C ratio of 0.65.

Fig. 7.9: Crack patterns at maximum factored resistance corresponding to factored dead load plus 3.67 times service live load. Corrosion considered (Girder P1 of span 12W-13W)..

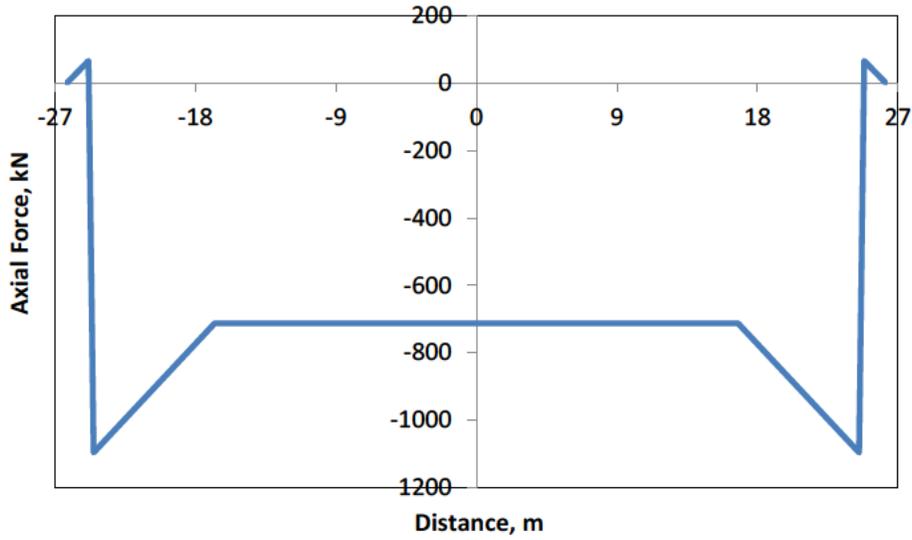
Figure 7.10 shows the resulting forces applied to simulate the the 1160 kN force in QP1.

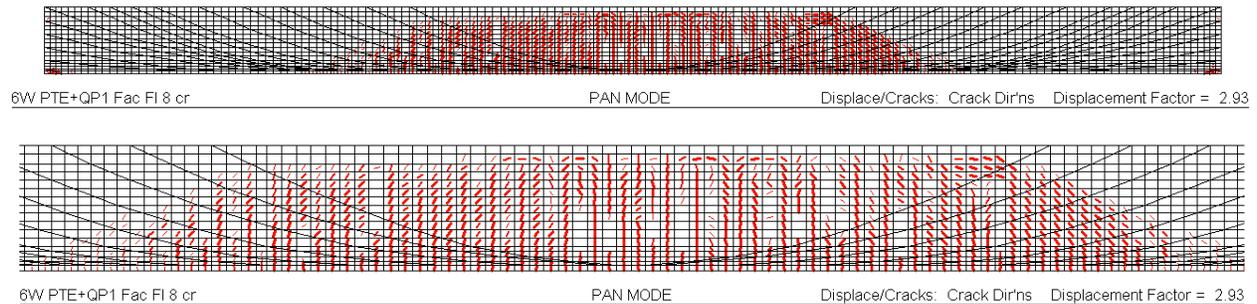
Figure 7.12 shows the crack patterns at the maximum factored loading that girder P1 can carry. The girder reached a factored load corresponding to factored dead loading plus 2.93 times the service live load. This represents the state of girder P1 of span 6W-7W with 8 strands corroded at midspan, giving a flexural D/C ratio of 0.76.

Fig. 7.12: Crack patterns at maximum factored resistance corresponding to factored dead load plus 2.93 times service live load. Corrosion of 8 strands at midspan considered (Girder P1 of span 6W-7W).

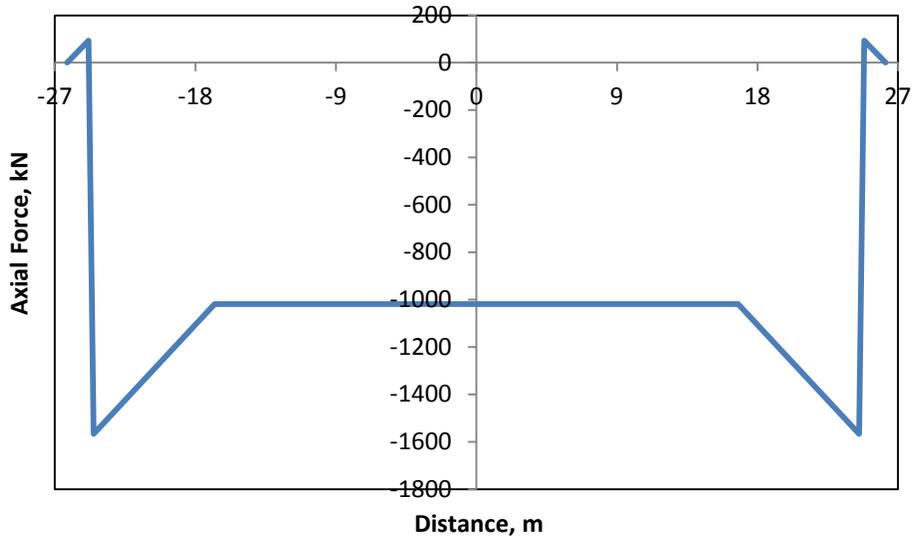
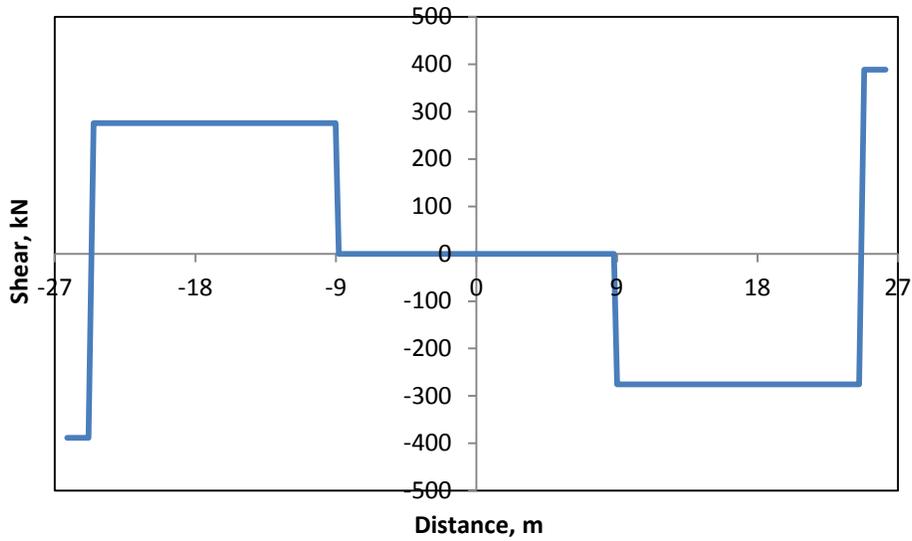
Figure 7.13 shows the resulting forces applied to simulate the the 1660 kN force in QP1.

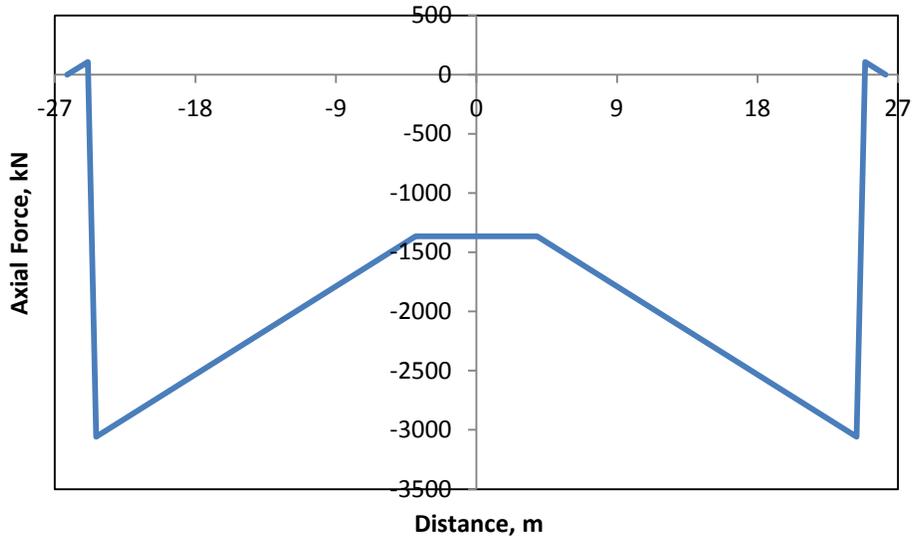
Figure 7.14 shows the resulting axial force and shear forces acting on girder P7 in span 32W-33W due to the unsymmetrically applied PTE forces in P1 and P7.

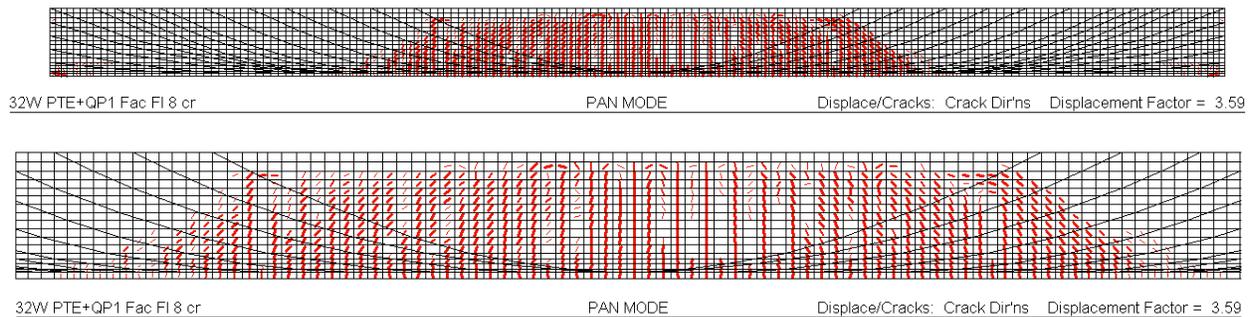
Figure 7.15 shows the crack patterns at the maximum factored loading that girder P7 can carry. The girder reached a factored load corresponding to factored dead loading plus 3.59 times the live load. This represents the state of girder P7 of span 32W-33W with 8 strands corroded at midspan, giving a flexural D/C ratio of 0.65.

Fig. 7.15: Crack patterns at maximum factored resistance corresponding to factored dead load plus 3.59 times service live load. Corrosion of 8 strands at midspan considered (Girder P7 of span 32W-33W).

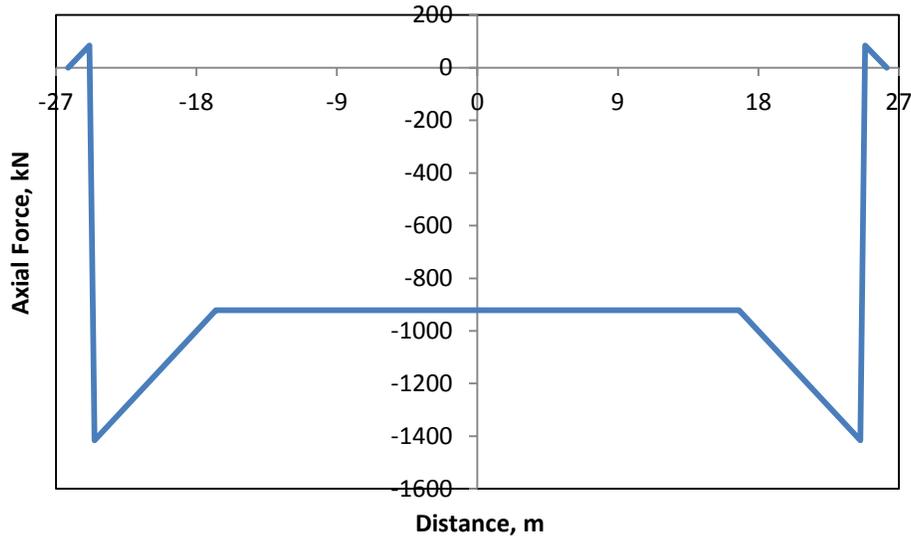
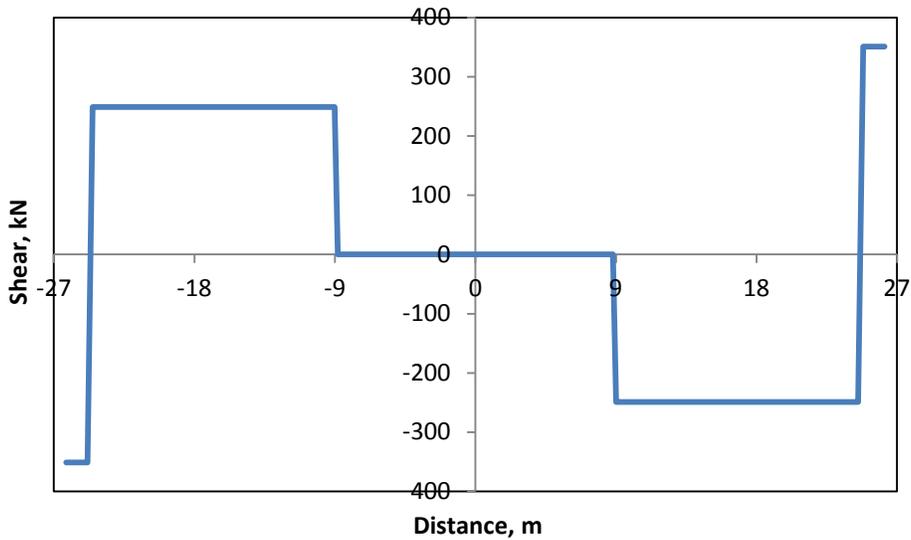
Figure 7.16 shows the resulting forces applied to simulate the 1500 kN force in QP1.

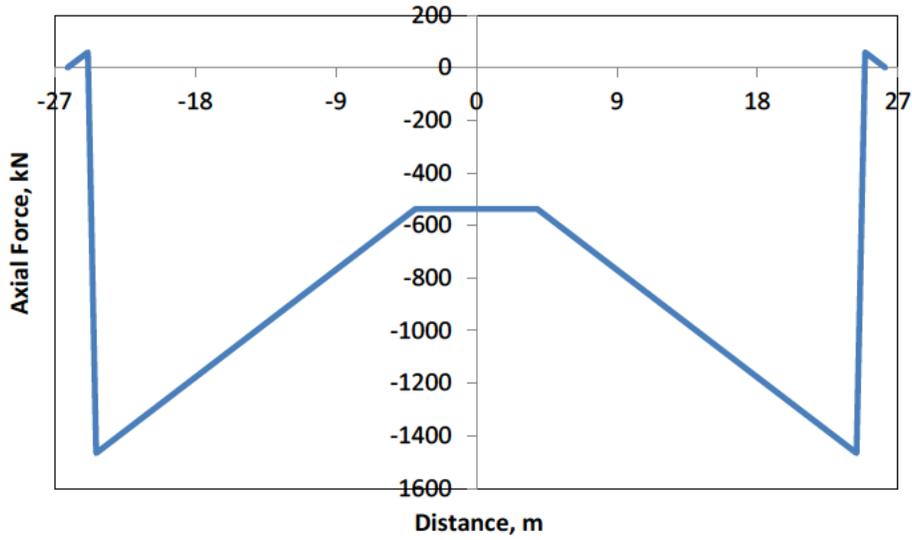
Figure 7.17 shows the resulting axial force and shear forces acting on girder P7 in span 26W-27W due to the unsymmetrically applied PTE forces in P1 and P7.

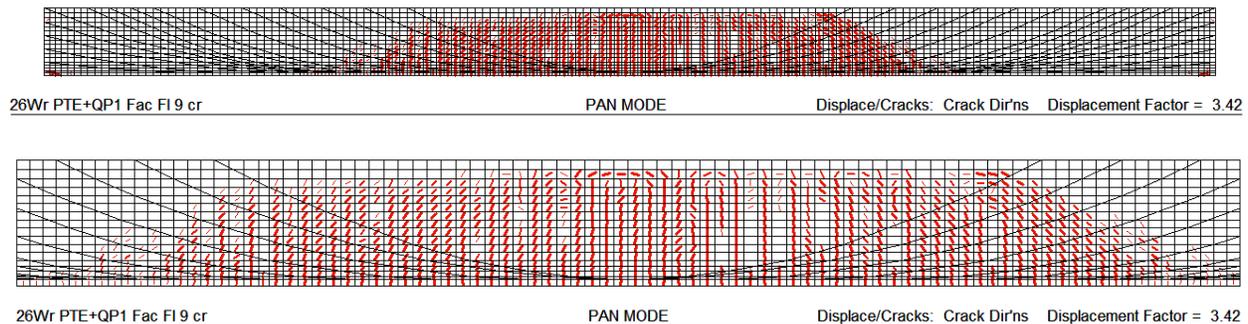
Figure 7.18 shows the crack patterns at the maximum factored loading that girder P7 can carry. The girder reached a factored load corresponding to factored dead loading plus 3.42 times the live load. This represents the state of girder P7 of span 32W-33W with 9 strands corroded at midspan, giving a flexural D/C ratio of 0.69.

Fig. 7.18: Crack patterns at maximum factored resistance corresponding to factored dead load plus 3.42 times service live load. Corrosion of 9 strands at midspan considered (Girder P7 of span 26W-27W).

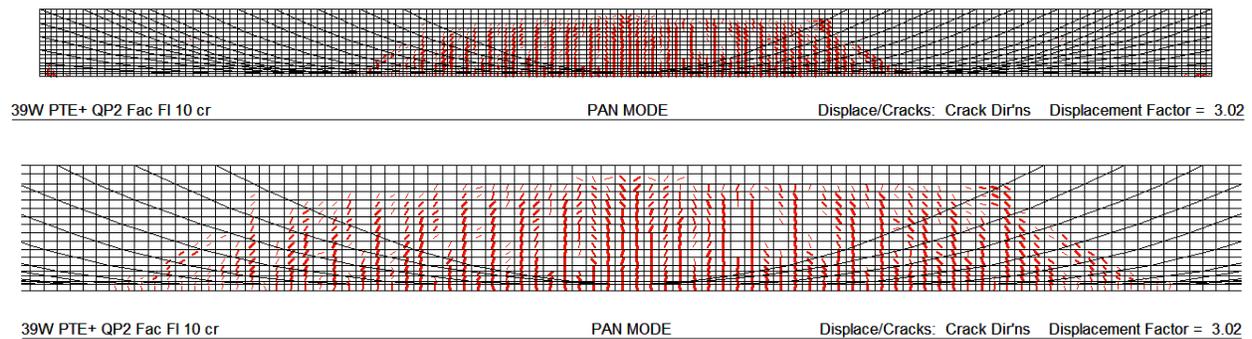
Failure was predicted when the live load factor reached 3.02, compared with a factor of 1.63 required by the CHBDC (CSA S6-14). This resulted in a D/C ratio of 0.75.

Fig. 8.6: Predicted failure at a live load factor of 3.02 of girder P1 in span 39W-40W assuming 10 tendons lost at midspan.

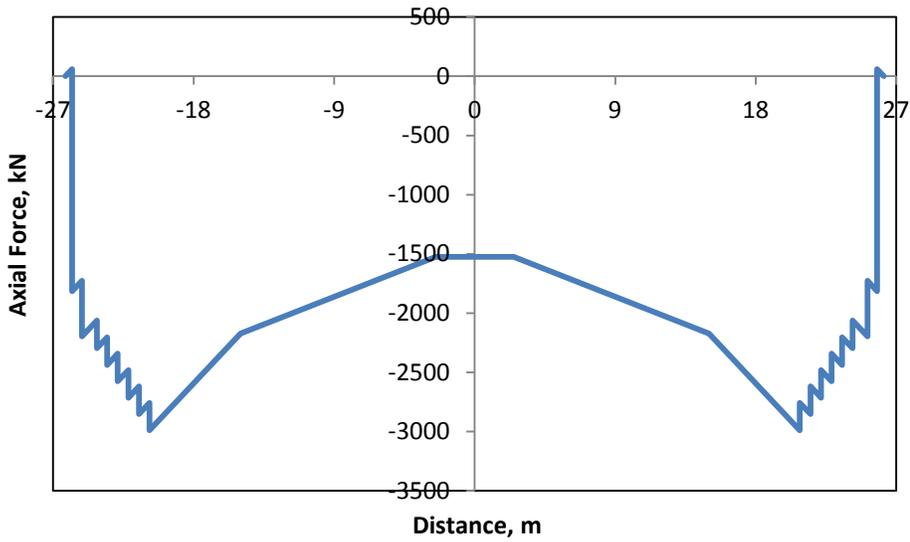
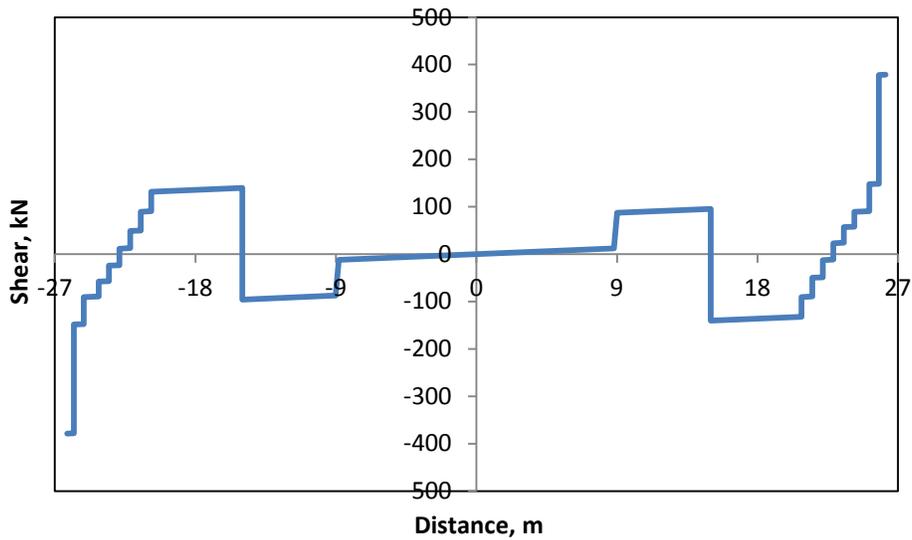
Figure 8.7 shows the resulting axial and shear force diagrams for the applied QP2 force of 3744 kN applied at the ends of each exterior girder.

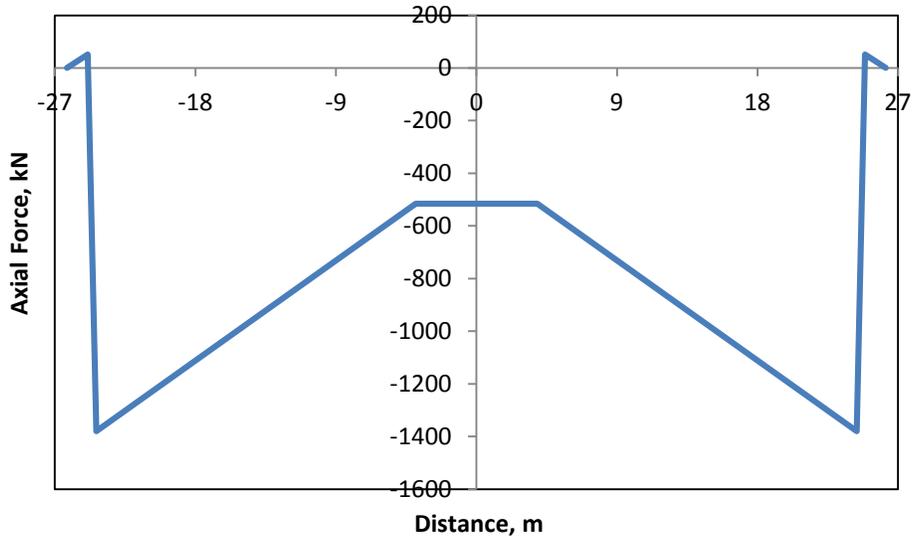
Figure 8.8 shows the resulting axial and shear force diagrams on girder P7 due to the applied PTE forces on P1 and P7.

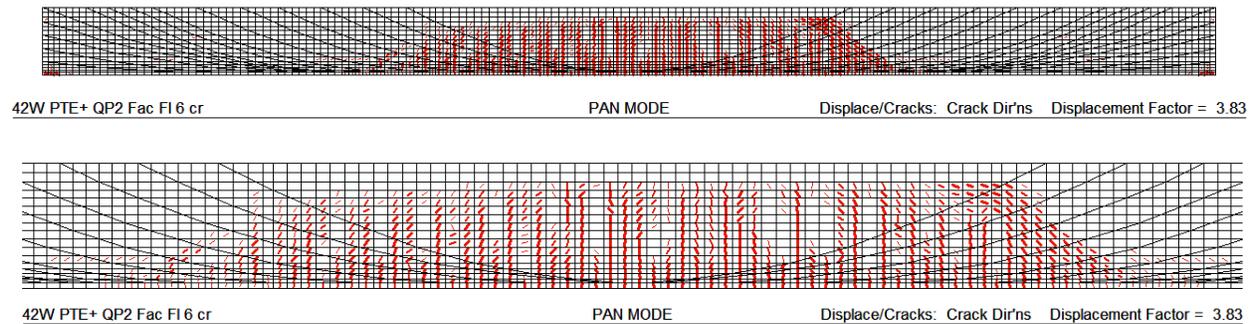
Failure was predicted when the live load factor reached 3.83, compared with a factor of 1.63 required by the CHBDC (CSA S6-14). This resulted in a D/C ratio of 0.64.

Fig. 8.9: Predicted failure at a live load factor of 3.83 of girder P7 in span 42W-43W assuming 6 tendons lost at midspan.

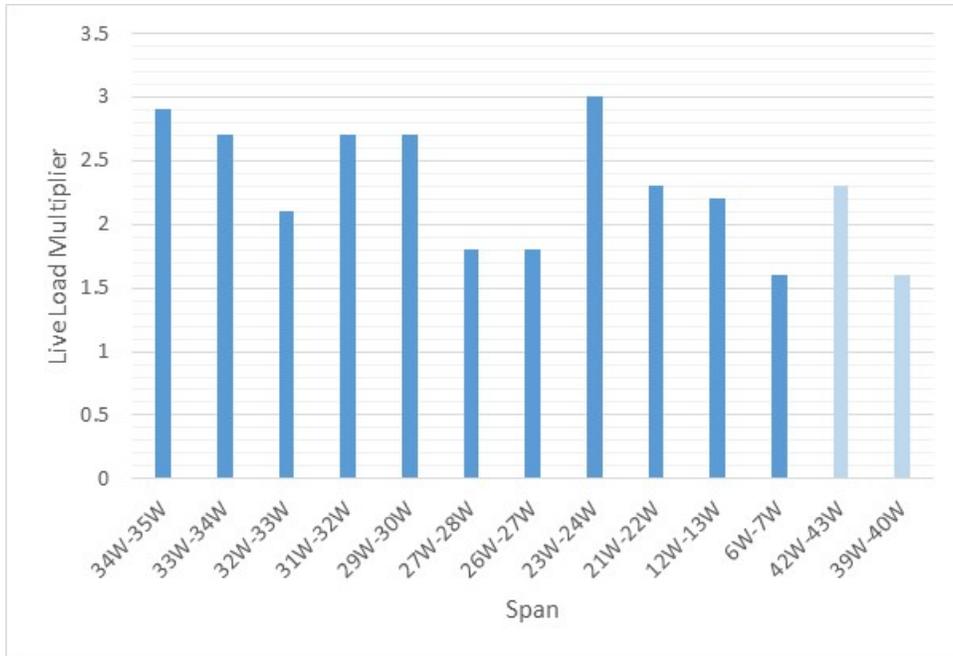
Figure 9.1 shows the factor, X, applied to the service live load that results in predicted flexural cracking. The 11 spans containing QP1 strengthening measures are shown in dark blue and the 2 spans with QP2 strengthening measures are shown in light blue (on the right in Fig. 9.1). These factors are all above 1.5 for the spans considered.

Fig. 9.1: Factor, X, on service live load to cause flexural cracking at midspan.

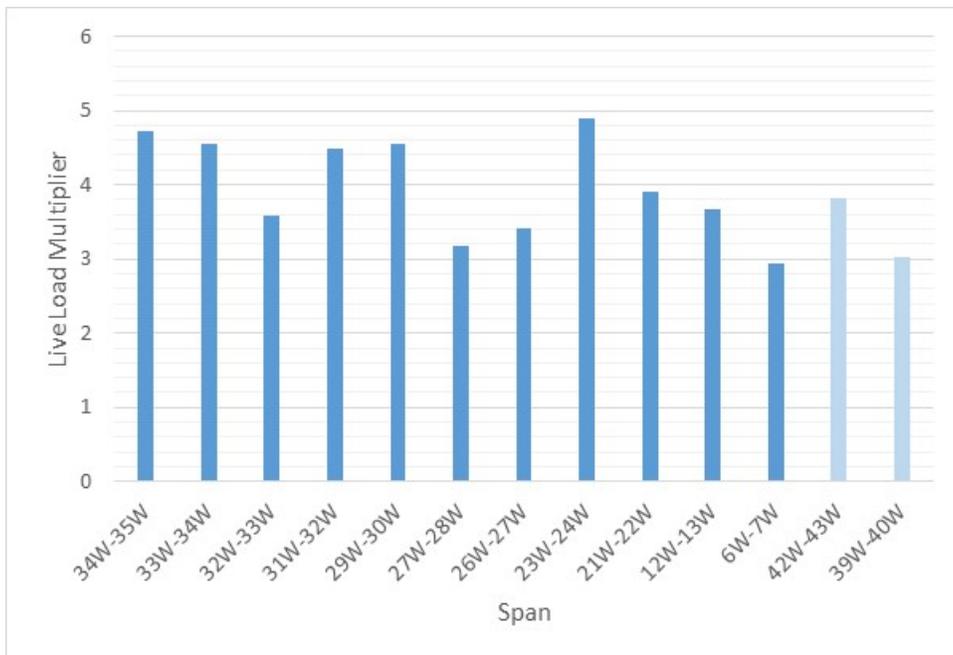
Figure 9.2 shows the factor, X, applied to the service live load that results in predicted flexural ultimate at midspan. These factors are all above the CSA S6 required live load factor of 1.63.

Fig. 9.2: Factor, X, on service live load to cause flexural failure at midspan.

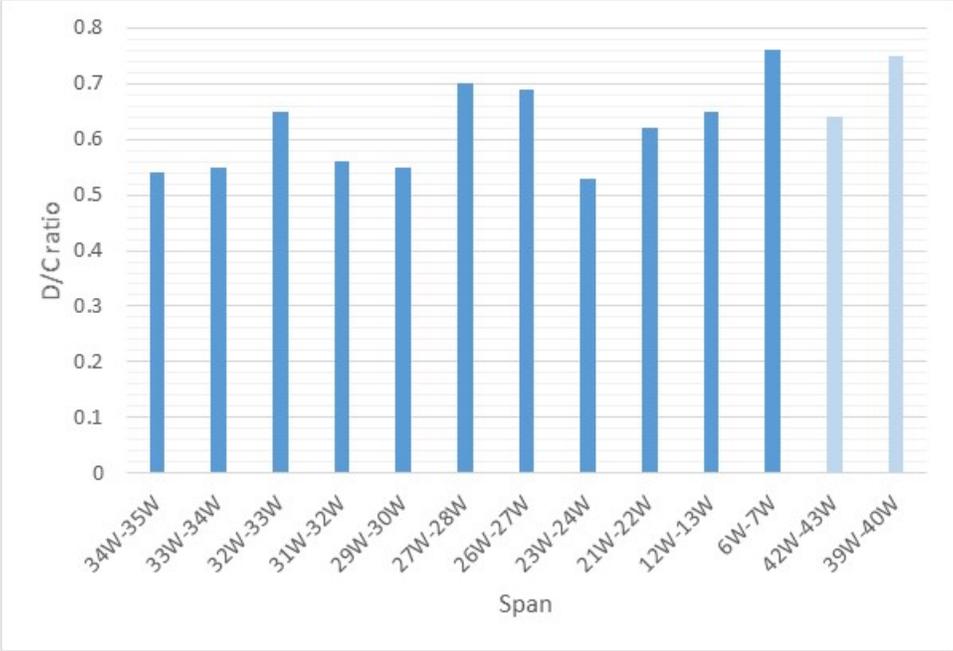
Figure 9.3 shows the variation in the predicted values of demand-to-capacity (D/C) ratios for the spans in Section 5 with either QP1 or QP2. There are 3 spans having predicted D/C ratios equal to or above 0.70.

Fig. 9.3: Predicted D/C ratios for flexure at midspan.

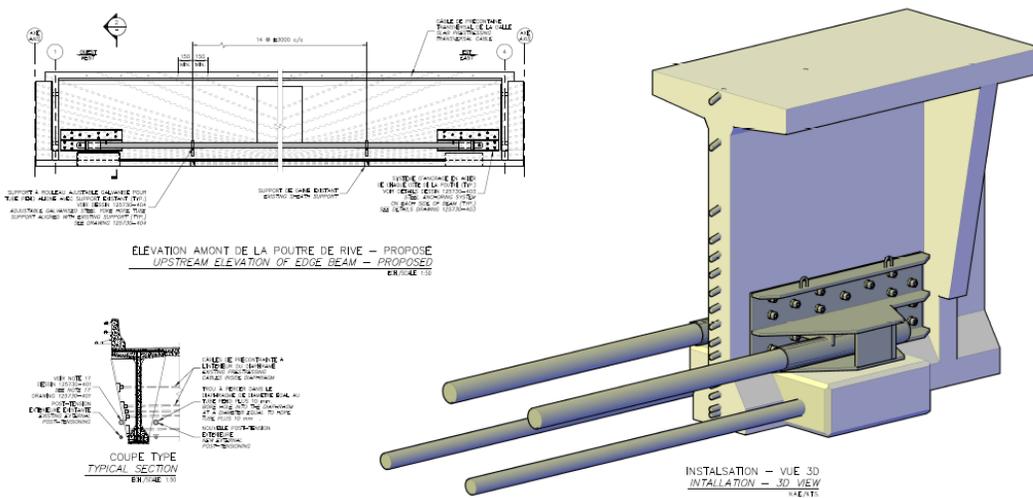
Figure 10.1 shows the details of the PTE2 strengthening measures. This additional external post-tensioning is applied to the girder above the level of existing PTE. The steel anchorage block is bolted to the web of the girder

Fig. 10.1: Details of PTE2 strengthening (DESSAU drawing number 125730-402, 2013)

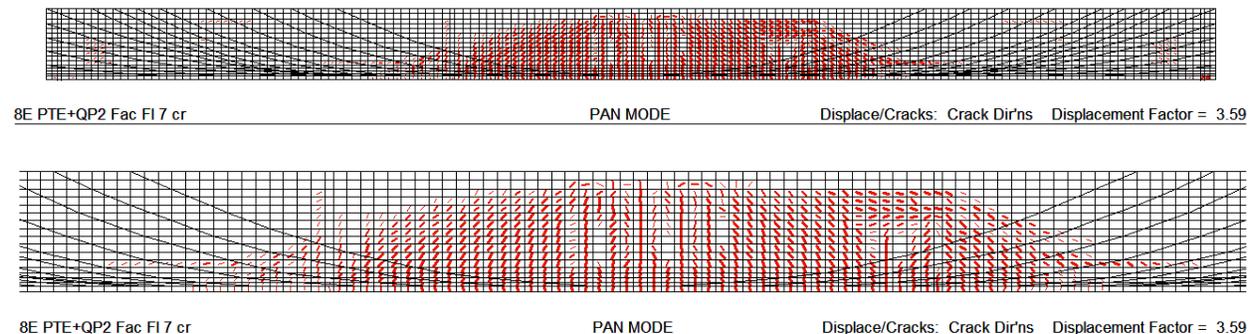
Figure 10.2 shows the cracking at the predicted maximum load carrying capacity of Girder P7. Failure is predicted to occur under factored dead load plus 3.59 times the live load. The girder is predicted to fail by flexural yielding in the midspan region. At this maximum load inclined shear cracks are also predicted to occur. The predicted D/C ratio is 0.66.

Fig. 10.2: Predicted failure of girder P7 in span 8E-9E at a live load factor of 3.59 assuming 7 tendons lost at midspan.

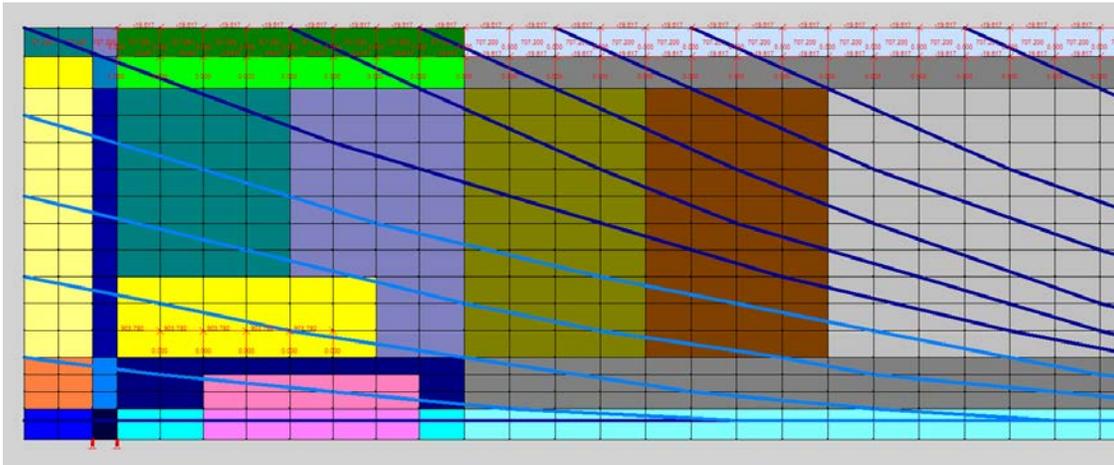
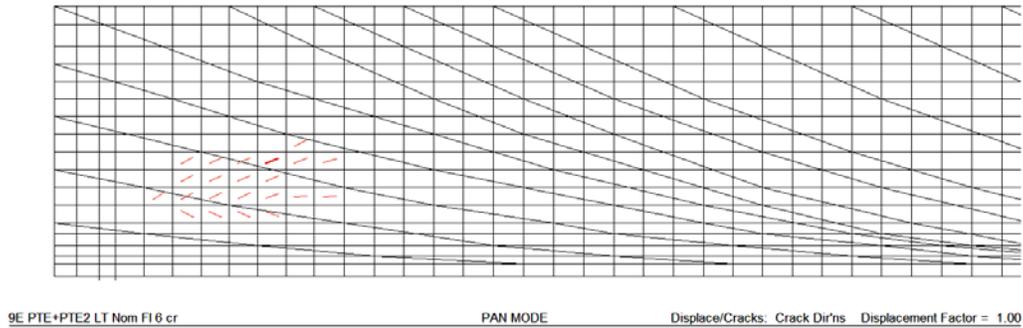
Flexural cracking is predicted to occur at a load corresponding to 2.9 and 2.5 times the live loading for short term and long-term predictions, respectively. Figure 10.3 shows the modelling of the steel plate anchorage of the PTE2 (bright yellow rectangles) with the PTE2 forces applied along the length of the steel plate. Figure 10.3 also shows the predicted cracking in Girder P1 at service load. The cracks radiating out from the anchor plate are due to the spreading of the compressive stresses into the web of the girder producing "bursting" tensile stresses. The maximum predicted crack width is 1 mm just above the plate.

Fig. 10.3 Modelling of anchorage of PTE2 in Girder P1 of Span 9E-10E and predicted cracks in anchorage region of PTE2 at service load.
