SECTION 5, 7A and 7B OF CHAMPLAIN BRIDGE
- 2D NON-LINEAR ANALYSES OF EDGE GIRDERS

REPORT SUBMITTED TO:

Ponts Jacques Cartier et Champlain Inc.

March 18, 2016

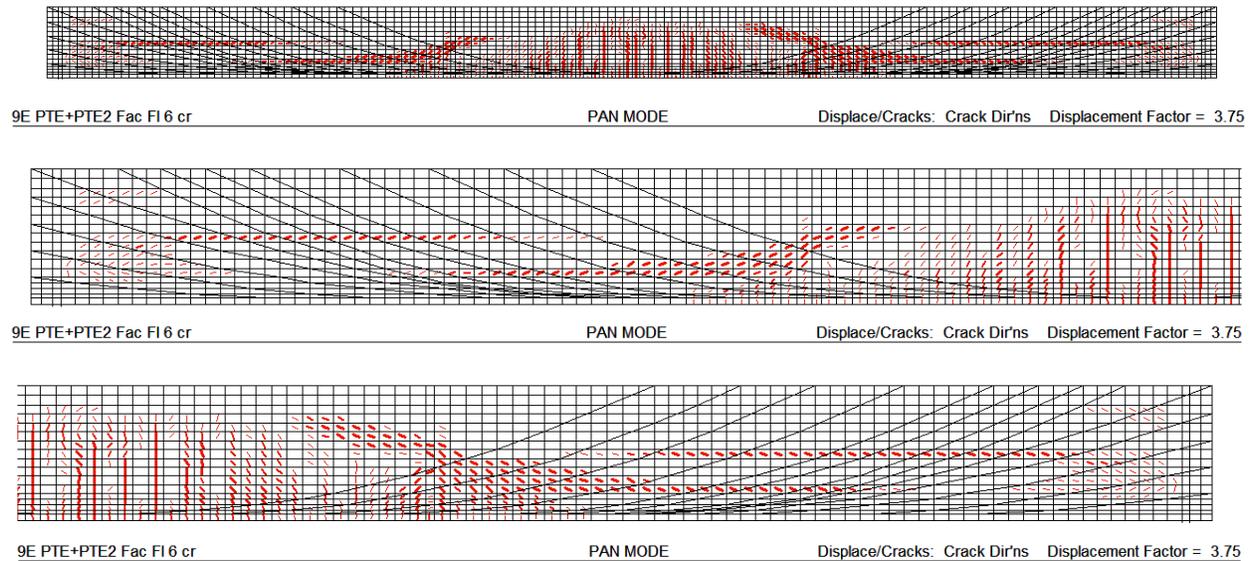
Figure 10.4 shows the cracking at the predicted maximum load carrying capacity of Girder P1. Failure is predicted to occur under factored dead load plus 3.75 times the live load. The girder is predicted to fail by flexural yielding in the midspan region. At this maximum load significant inclined shear cracks are also predicted to occur as well as longitudinal splitting cracks. It is noted that the FRP shear strengthening strips were not included in this analysis and hence the shear cracking at flexural ultimate would be better controlled. The predicted D/C ratio is 0.62.

Fig. 10.4: Predicted failure of girder P7 in span 9E-10E at a live load factor of 3.75 assuming 6 tendons lost at midspan.

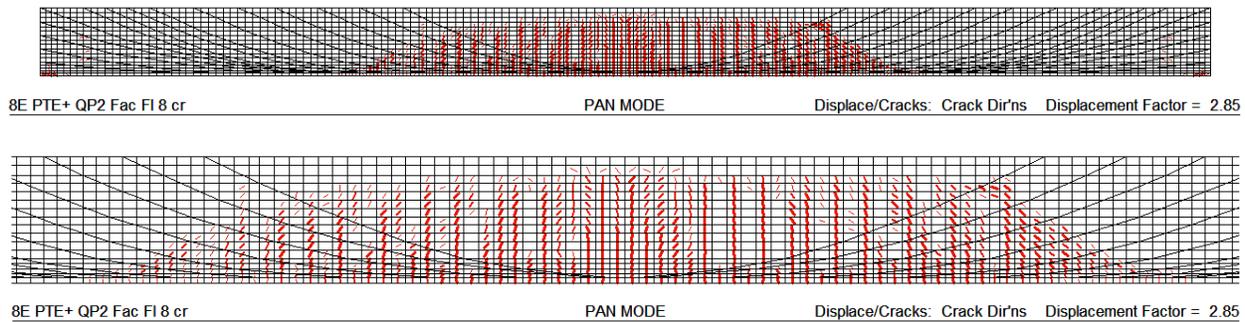
Figure 10.5 shows the cracking at the predicted maximum load carrying capacity of Girder P7. Failure is predicted to occur under factored dead load plus 2.85 times the live load. The girder is predicted to fail by flexural yielding in the midspan region. At this maximum load inclined shear cracks are also predicted to occur. The predicted D/C ratio is 0.77.

Fig. 10.5: Predicted failure of girder P7 in span 7E-8E at a live load factor of 2.85 assuming 8 tendons lost at midspan.

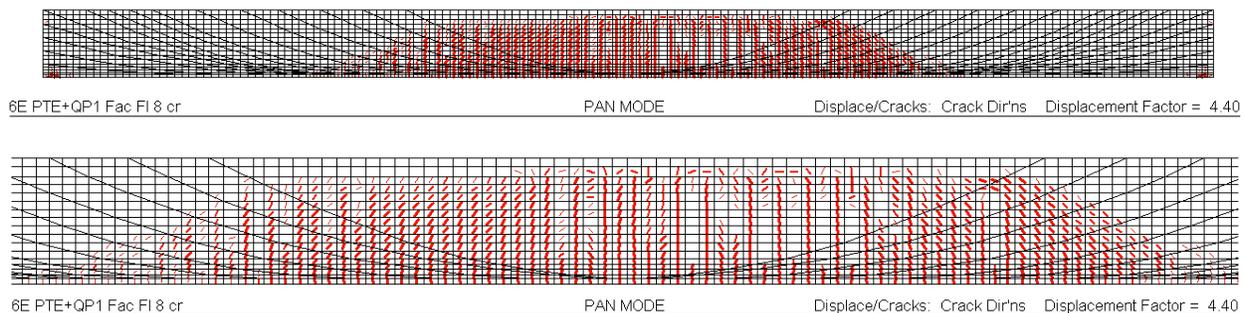
Fig. 10.6: Predicted failure of girder P7 in span 6E-7E at a live load factor of 4.40 assuming 8 tendons lost at midspan.

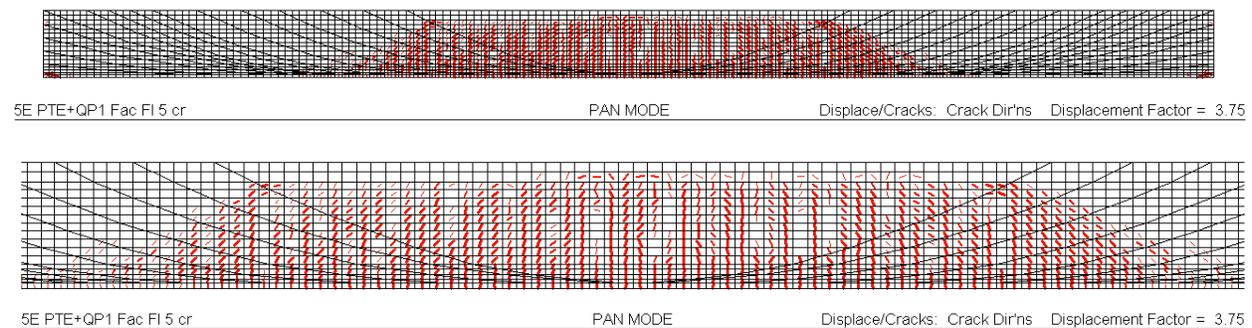
Fig. 10.7: Predicted failure of girder P7 in span 5E-6E at a live load factor of 3.75 assuming 5 tendons lost at midspan.

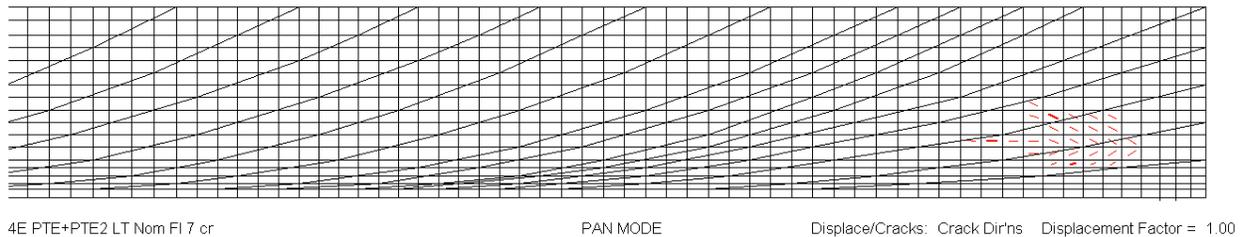
Fig. 10.8: Predicted cracks in anchorage region of girder P1 due to PTE2 at service load.

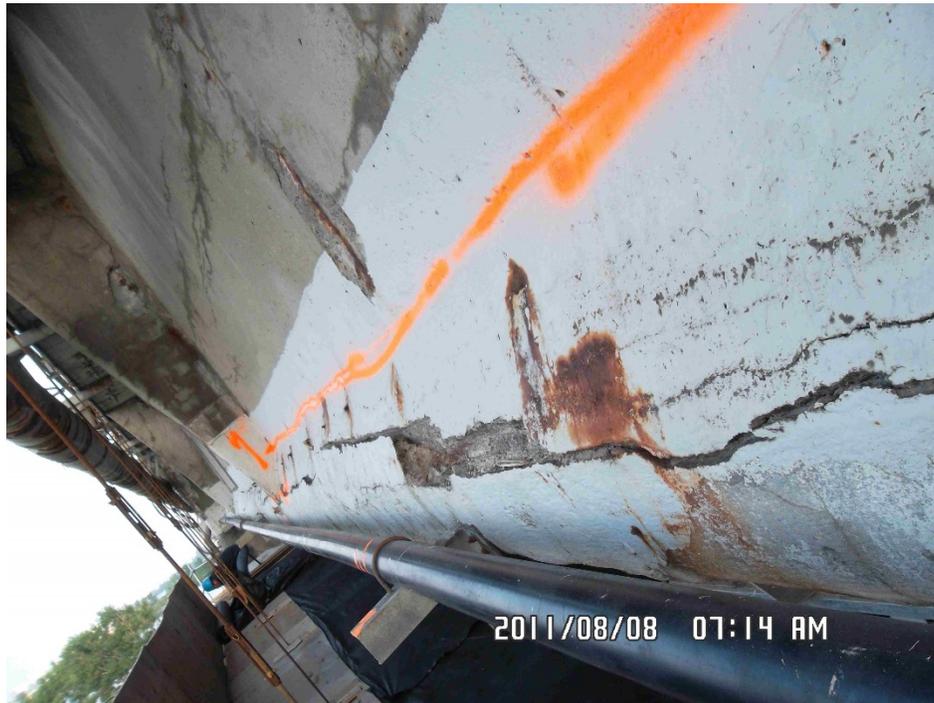
Fig. 11.2: Condition of bottom flange of Girder P7 in span 10E-11E in August 2011.

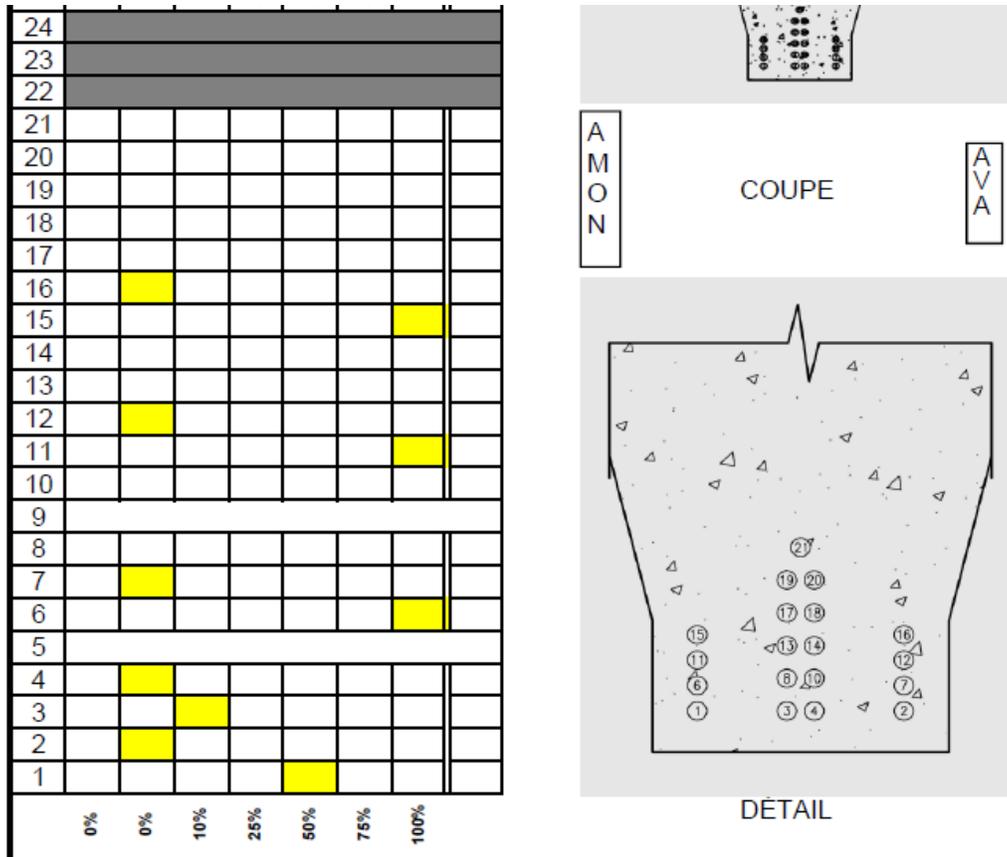
Fig. 11.3: Inspection of tendons in girder P7 of span 10E-11E (Axor-Genivar, Contrôle qualité - Câbles de post-tension des poutres du pont Champlain - Section 7B, 15-09-2011).

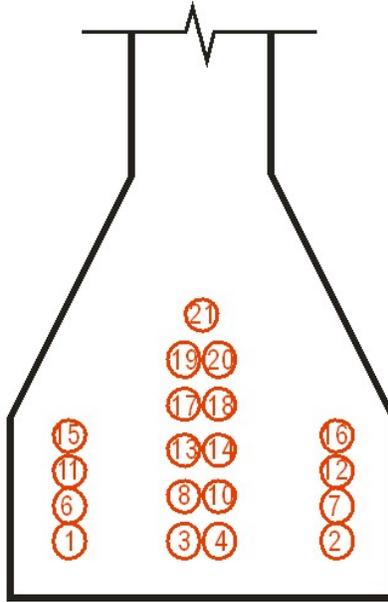
Fig. 11.4: Tendons 1, 6, 11 and 15 assumed ineffective in P7 of span 10E-11E

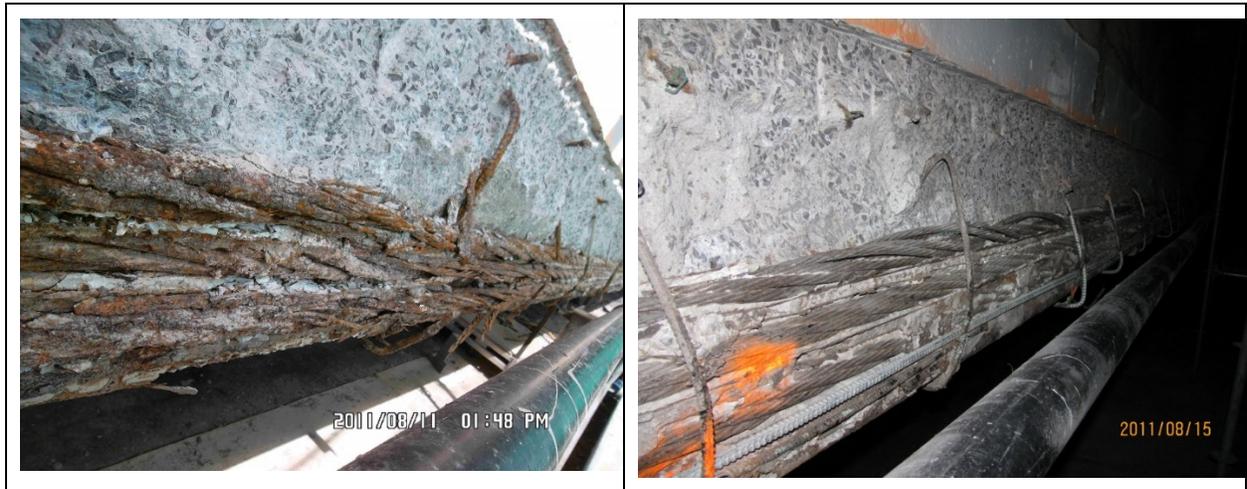
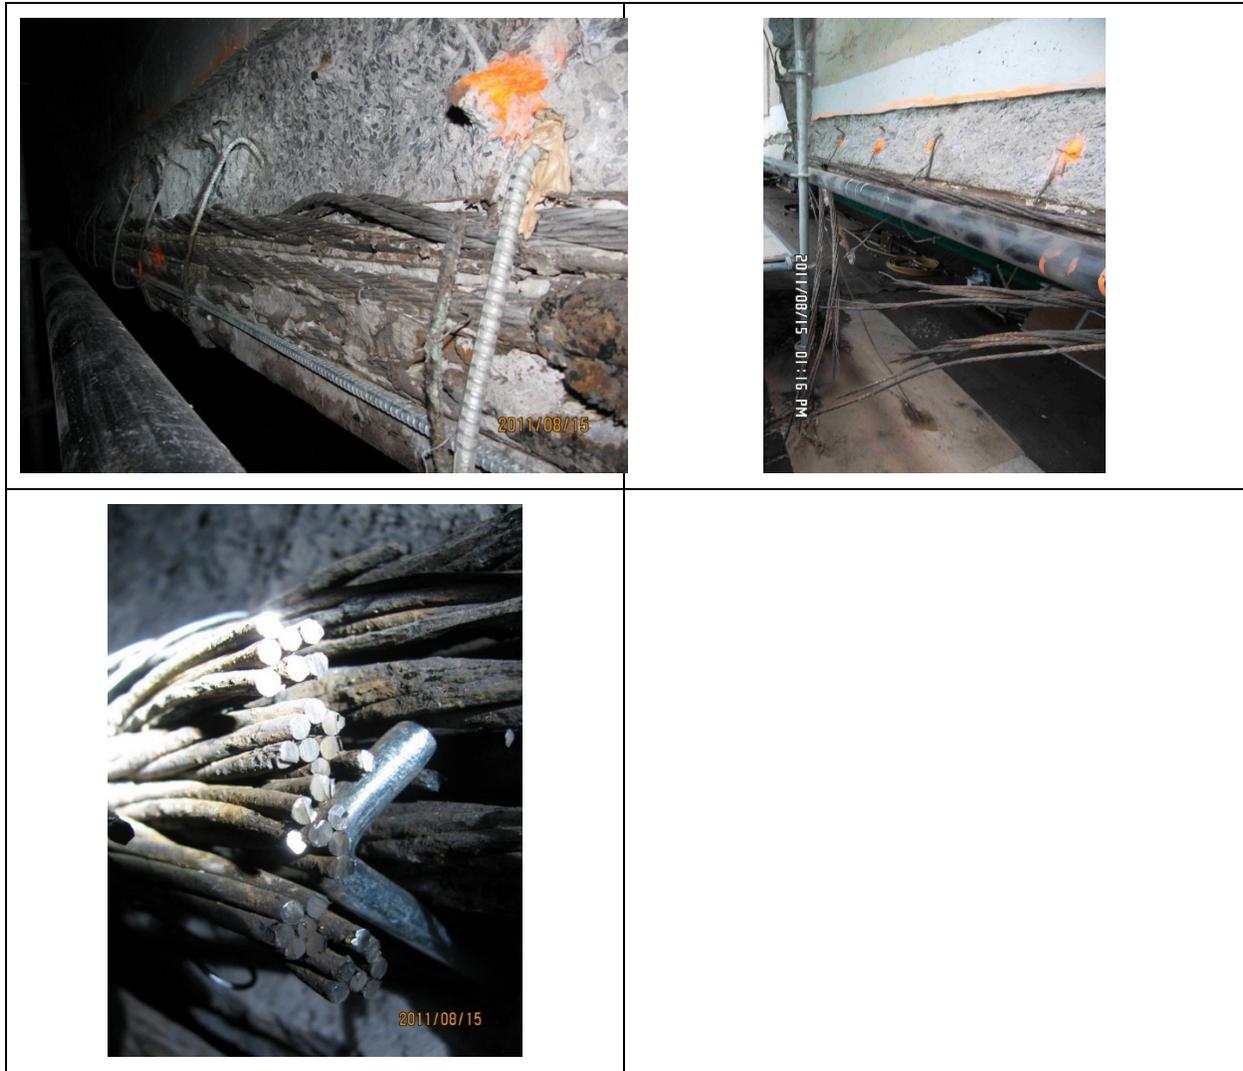
Fig. 11.5: Concrete removal and condition of GTM strands during repair of bottom flange of Girder P7 in span 10E-11E in August 2011.

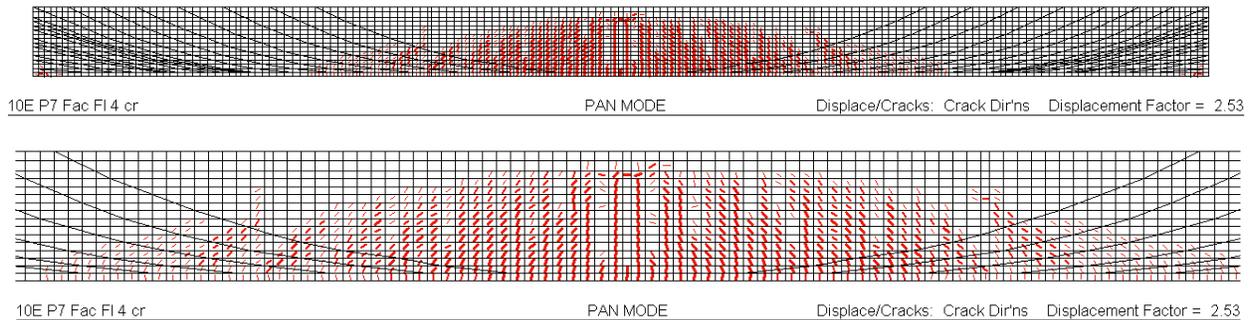
Fig. 11.7: Cracking of girder P7 in span 10E-11E at flexural ultimate.

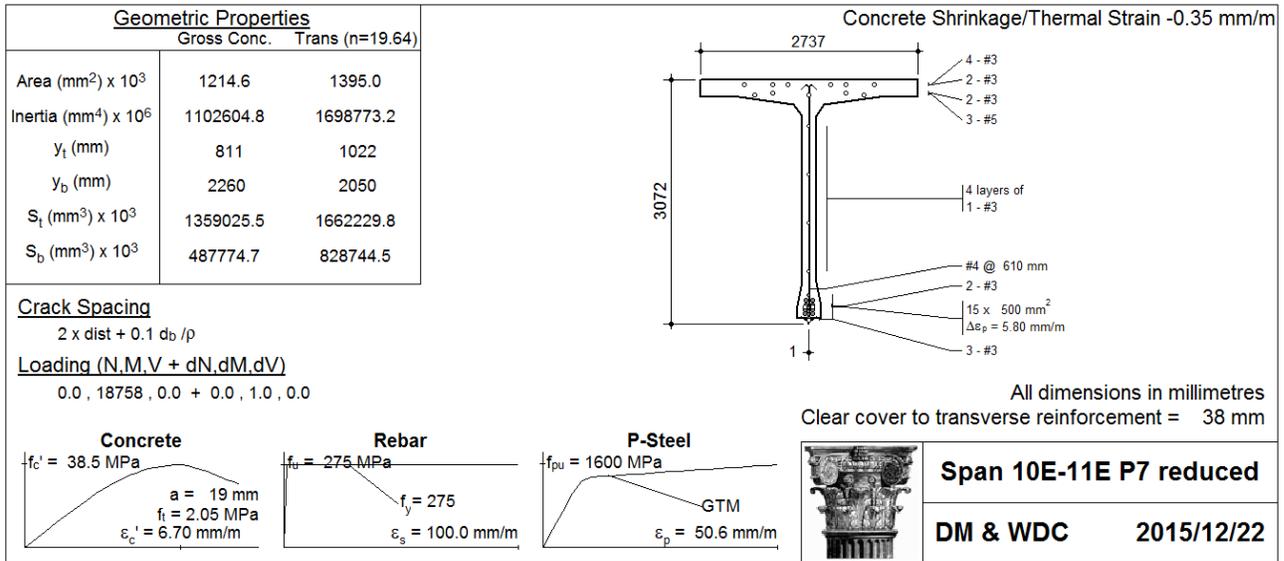
Fig. 11.8: Cross-sectional details of Girder P7 with reduced bottom flange dimensions due to concrete removal and the loss of 4 strands due to corrosion

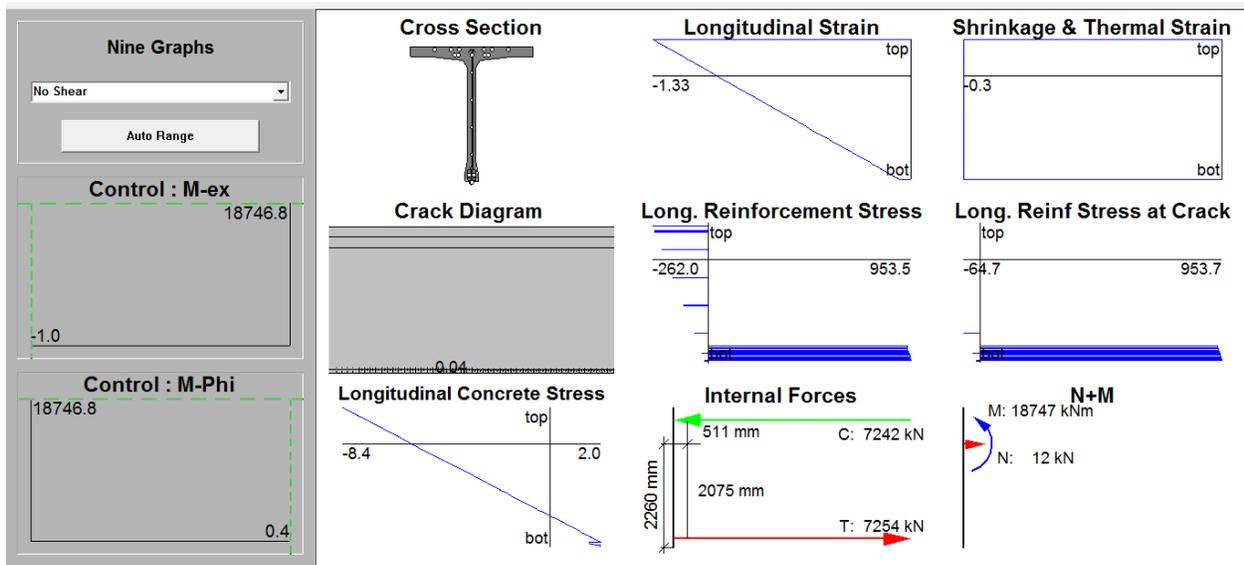
Fig. 11.9: Predicted cracking of Girder P7 with reduced flange dimensions and loss of 4 tendons.

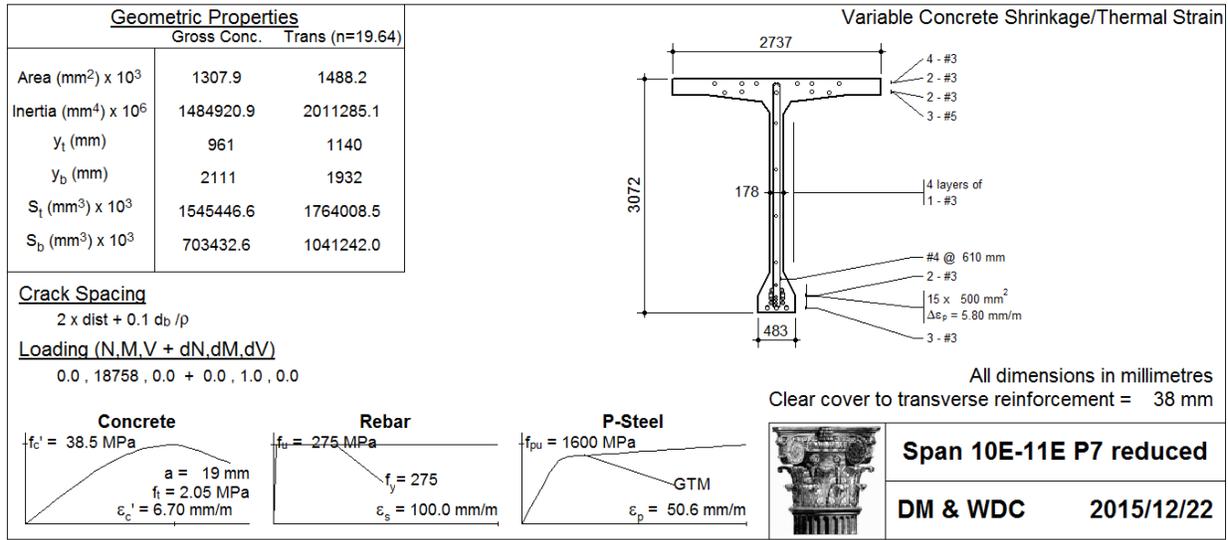
Fig. 11.10: Cross-sectional details of Girder P7 with repair concrete, additional shrinkage and the loss of 4 strands due to corrosion

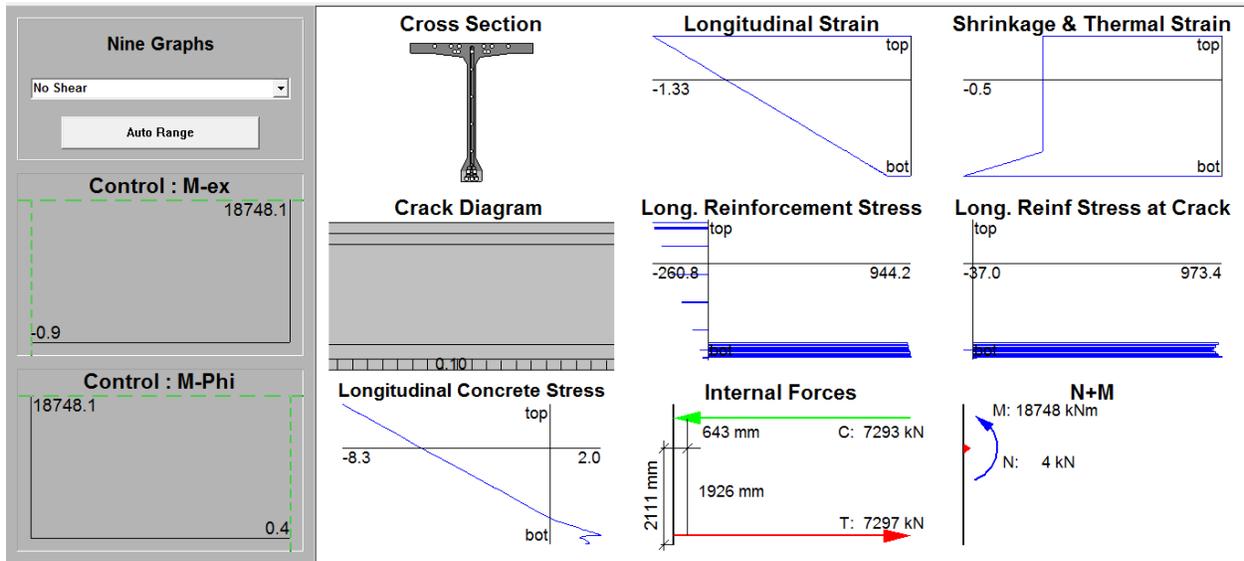
Fig. 11.11: Predicted cracking of Girder P7 with repair concrete and loss of 4 tendons.

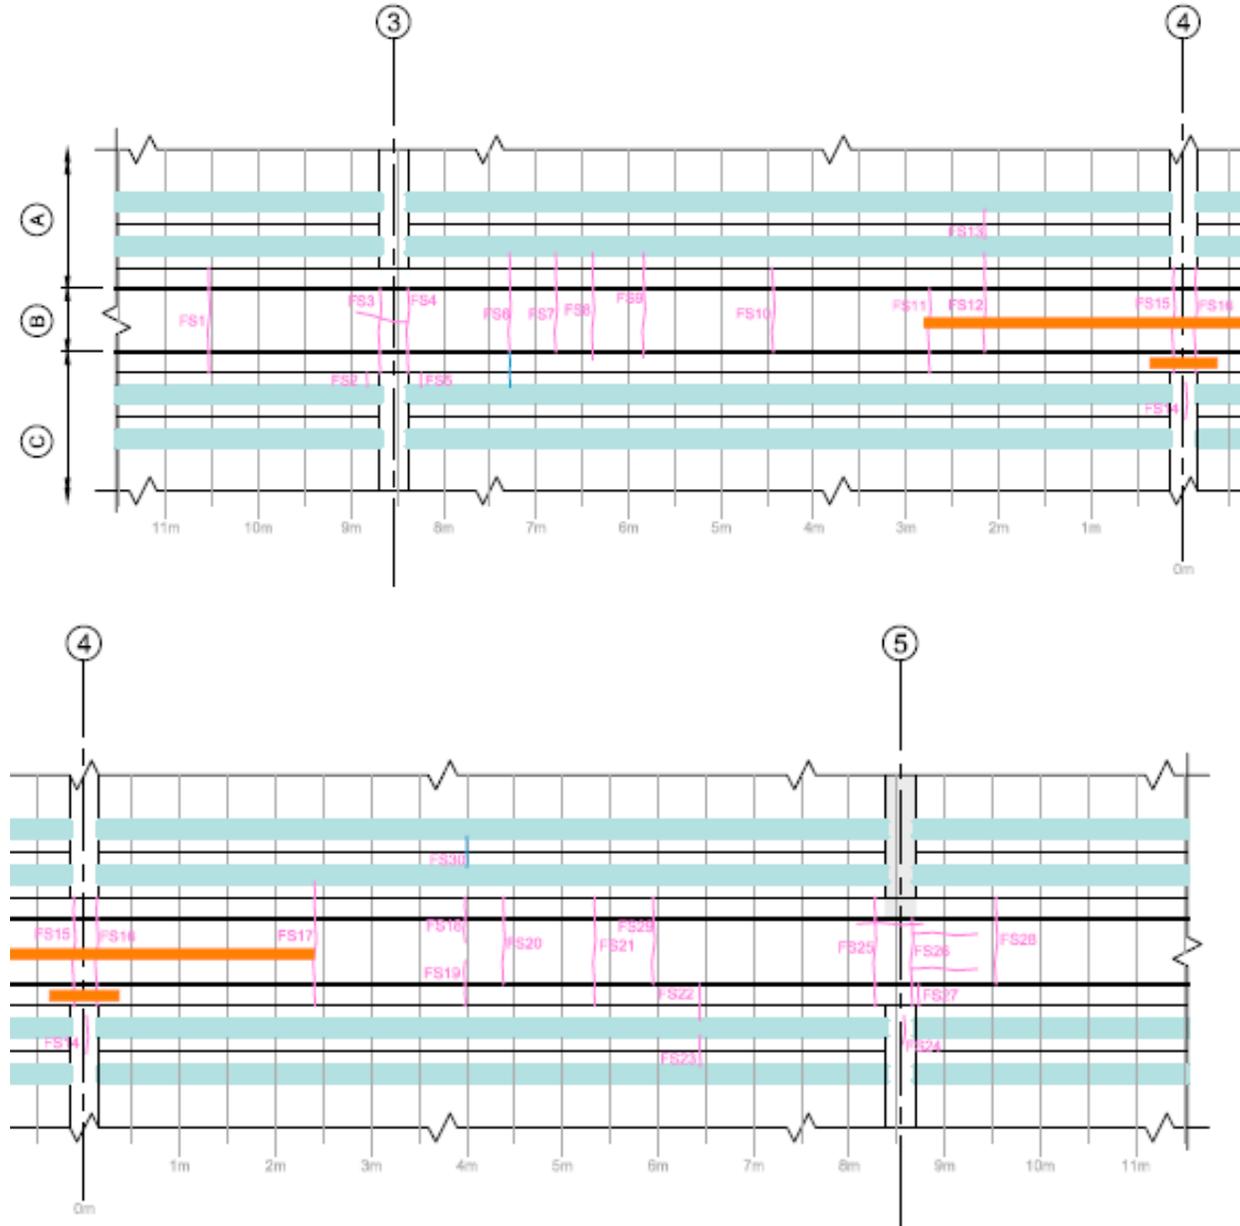
Fig. 11.12: Measured cracks in bottom flange of P7 of span 10E-11E (DESSAU | CIMA+ Rapport d'Inspection de Suivi CT 62057 24 sept, 2015)

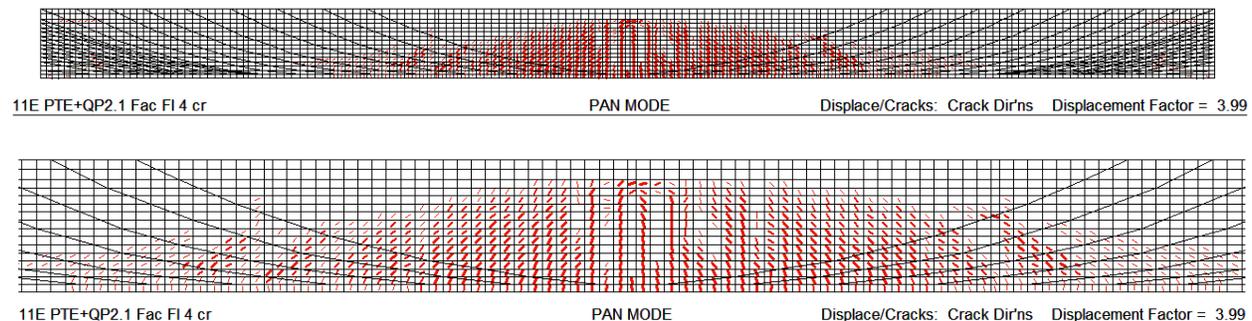
Fig. 11.14: Predicted failure of girder P7 in span 11E-12E at a live load factor of 3.75 assuming 4 tendons lost at midspan.

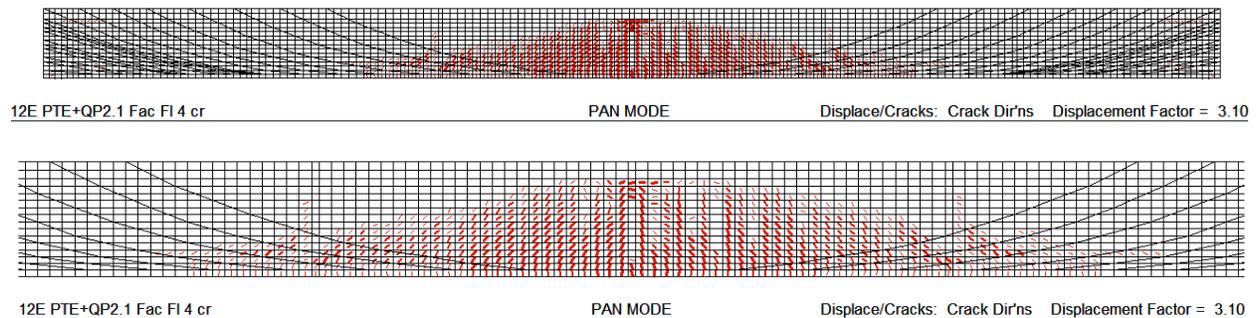
Fig. 11.15: Predicted failure of girder P7 in span 11E-12E at a live load factor of 3.10 assuming 4 tendons lost at midspan.

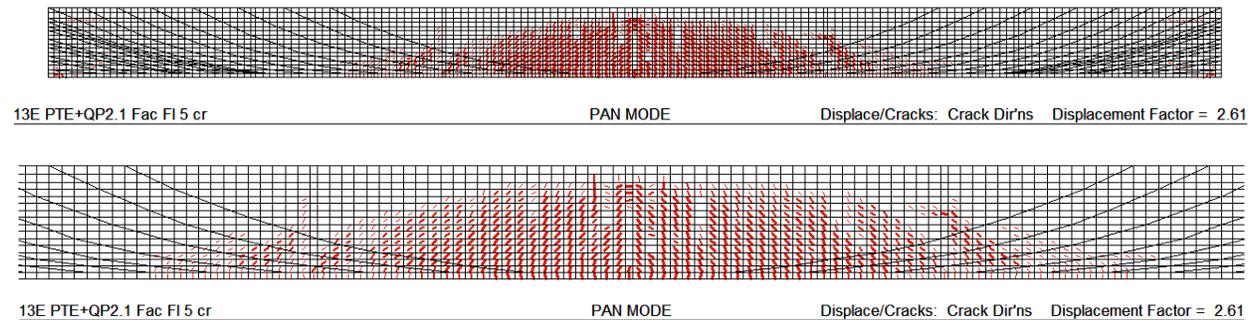
Fig. 11.16: Predicted failure of girder P7 in span 13E-14E at a live load factor of 2.61 assuming 4 tendons lost at midspan.

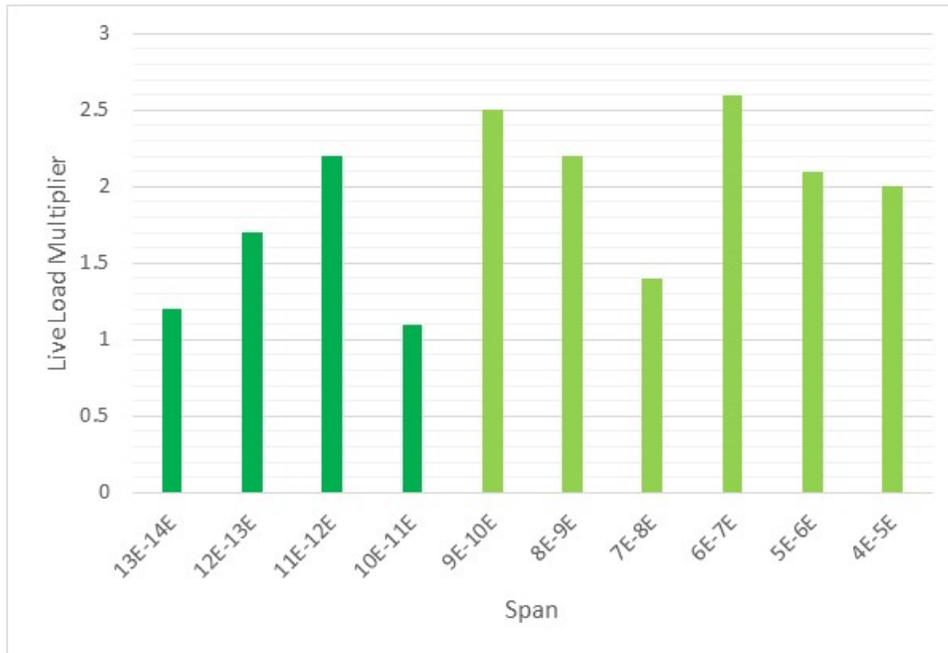
Fig. 12.1: Factor, X, on service live load to cause flexural cracking at midspan.

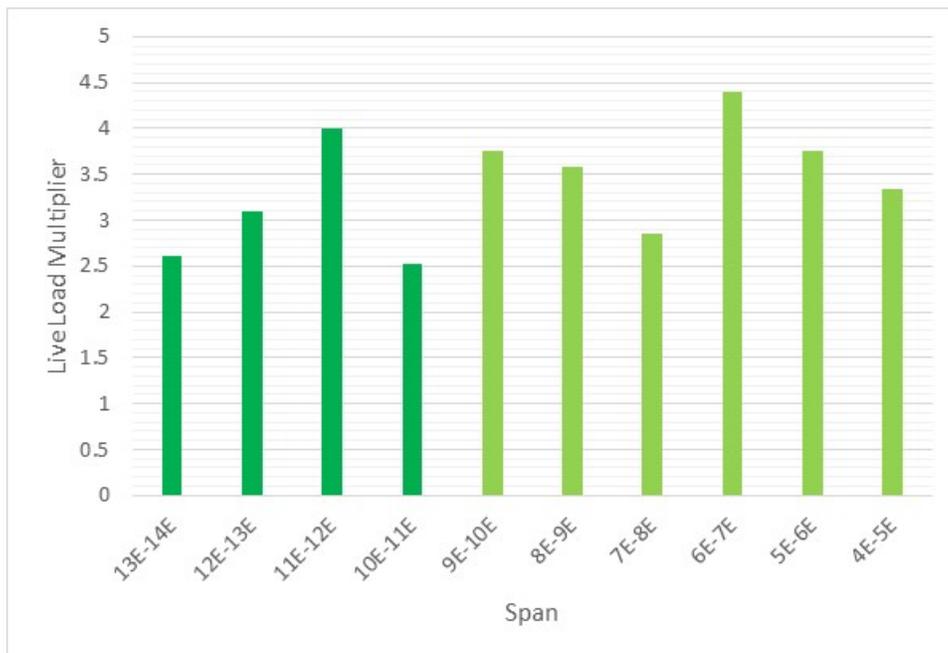
Fig. 12.2: Factor, X, on service live load to cause flexural failure at midspan.

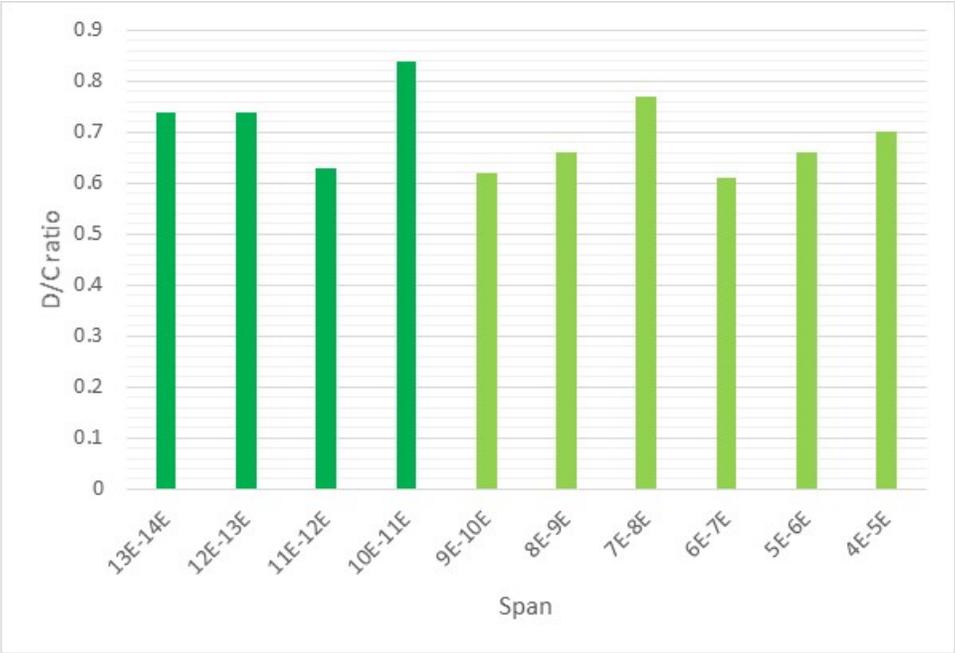
Fig. 12.3: Predicted D/C ratios for flexure at midspan.
